Town of Fremont Wetland Evaluation Report

Town of Fremont, NH
Conservation Commission

September 2007

WEST

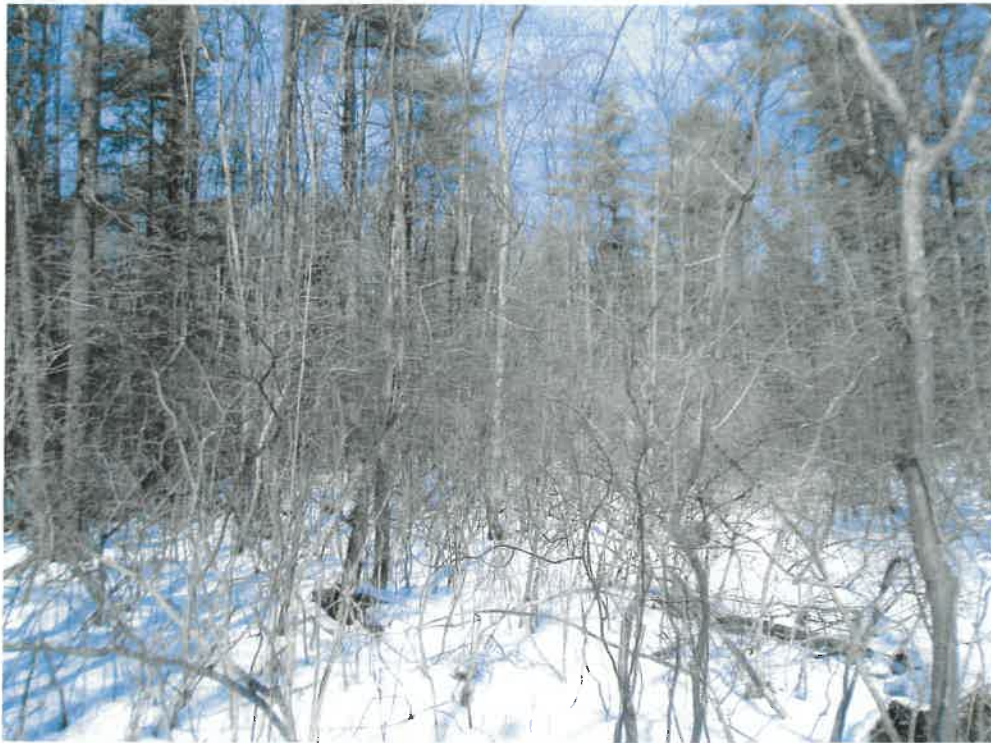
1. This is a view of Wetland #2 directed northwards. The two predominate layers in this wetland are mixed forest and scrub-shrub.

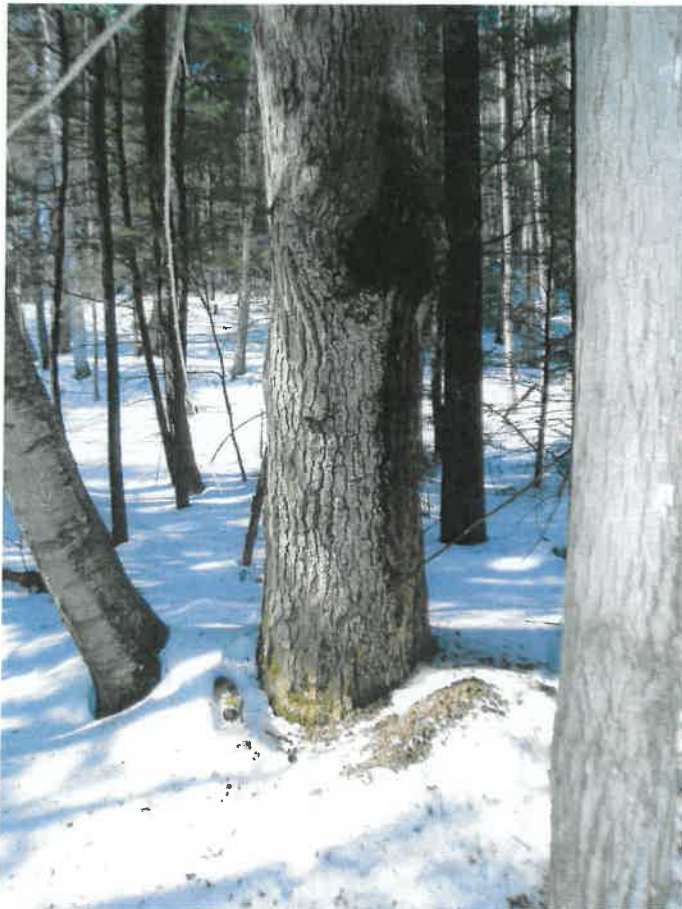
2. This photo shows a large 24" black gum located within the wetland. The large cavity (top center) is being utilized by a porcupine as a home. A large quantity of scat was noted at the base of the tree.

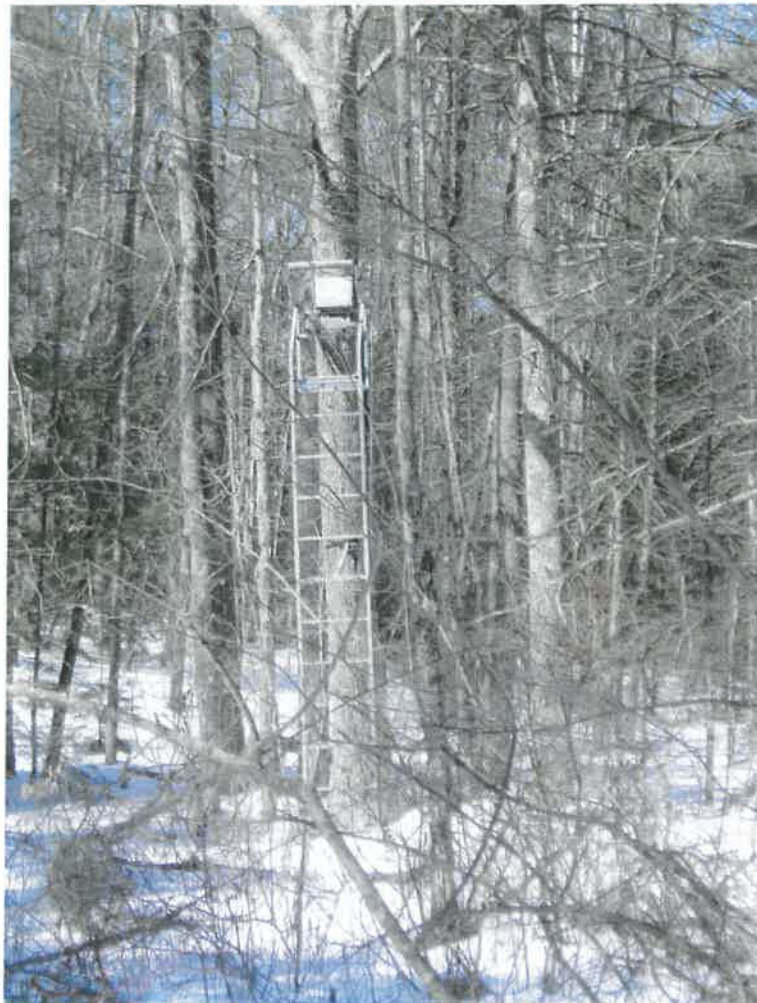
3. A deer stand was also noted within this wetland. Its location here suggests back and forth movement through this wetland by white-tailed deer. The scrub-shrub component provides critical cover.

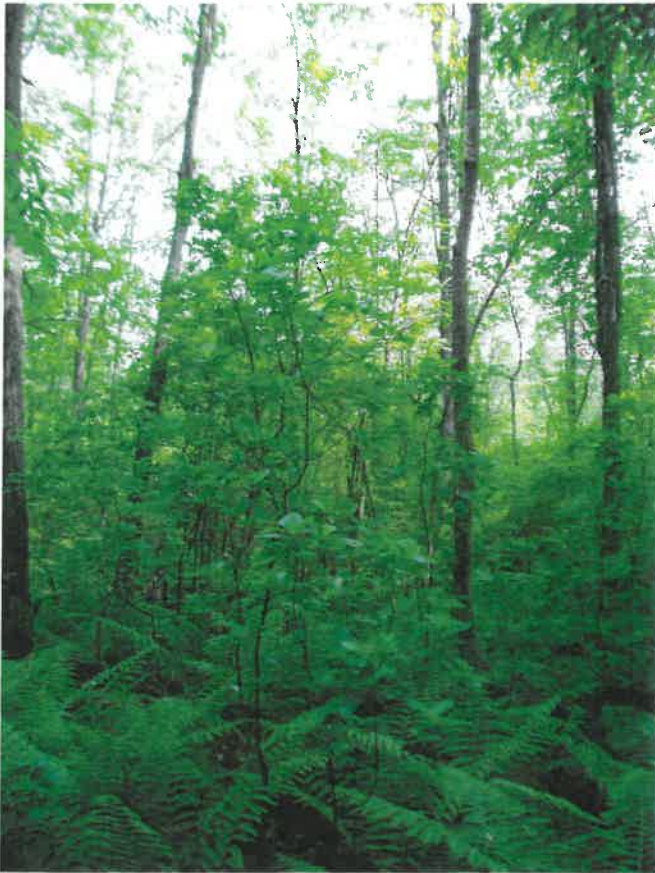
1. This is a view of Wetland #3 showing a very thick scrub-shrub understory.

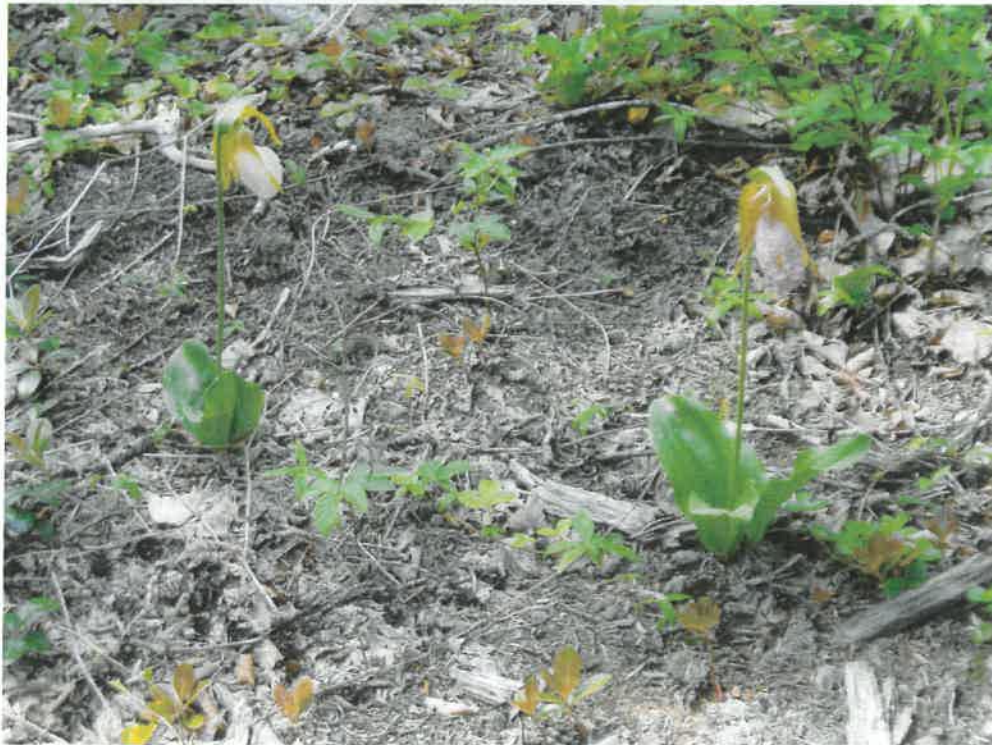
2. These pink lady slippers (a plant species of concern) were observed along the outside edge of Wetland #3.

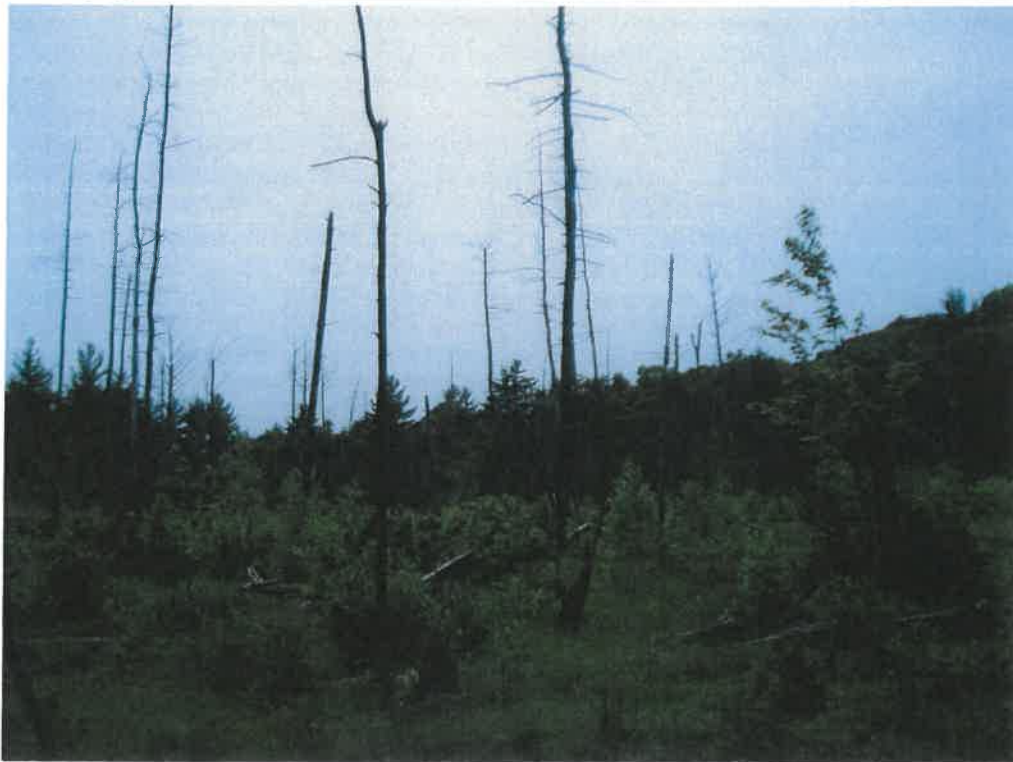
1. Wetland #4 was previously occupied by a colony of beaver. Its plant community is chiefly comprised of emergent marsh and scrub-shrub species. Interspersed within the wetland were many dead snags (trees that previously had been killed by the high water).

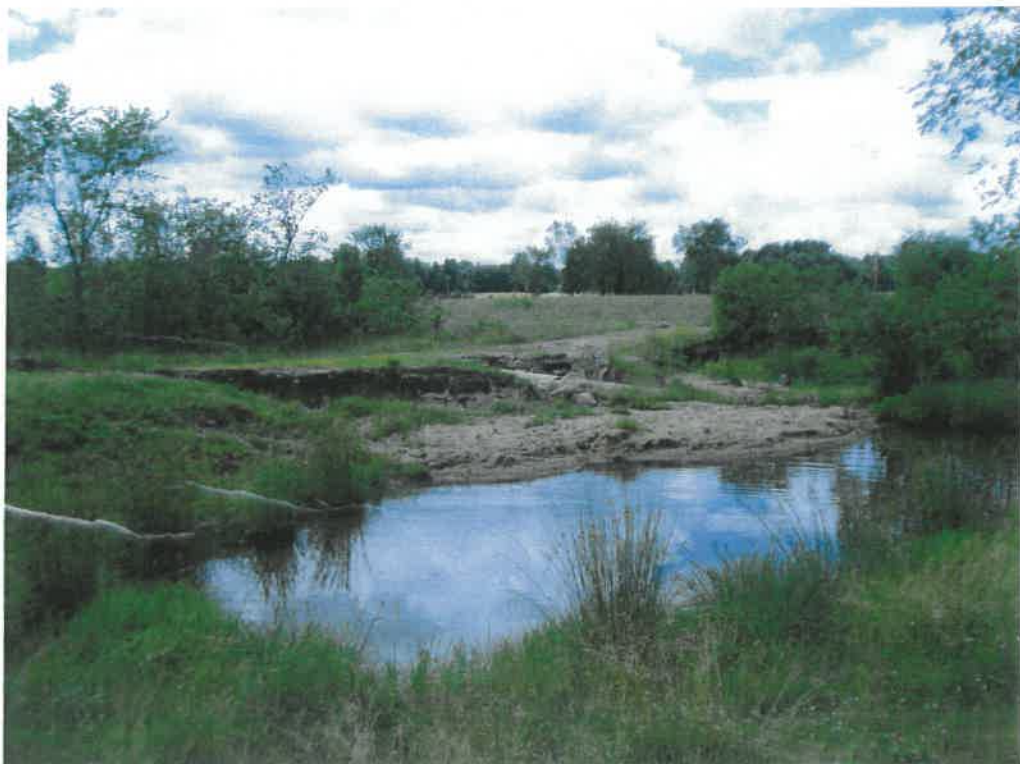
2. It appears that earlier flood events have caused disturbance (sediment deposition) in a section of this wetland where an access road was overtopped with water.

Restoration area size: Recent storm events have caused some sedimentation in the southern

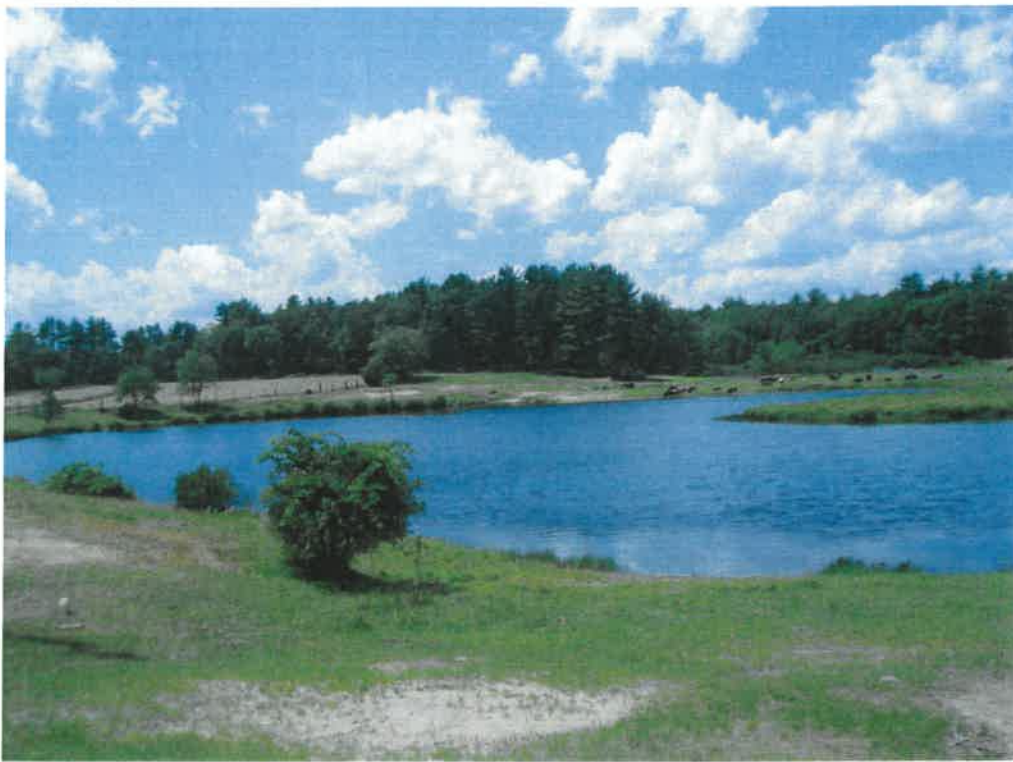
1. Wetland #6 is an excavated pond with a thin fringe of emergent vegetation. This wetland is surrounded by farm fields.

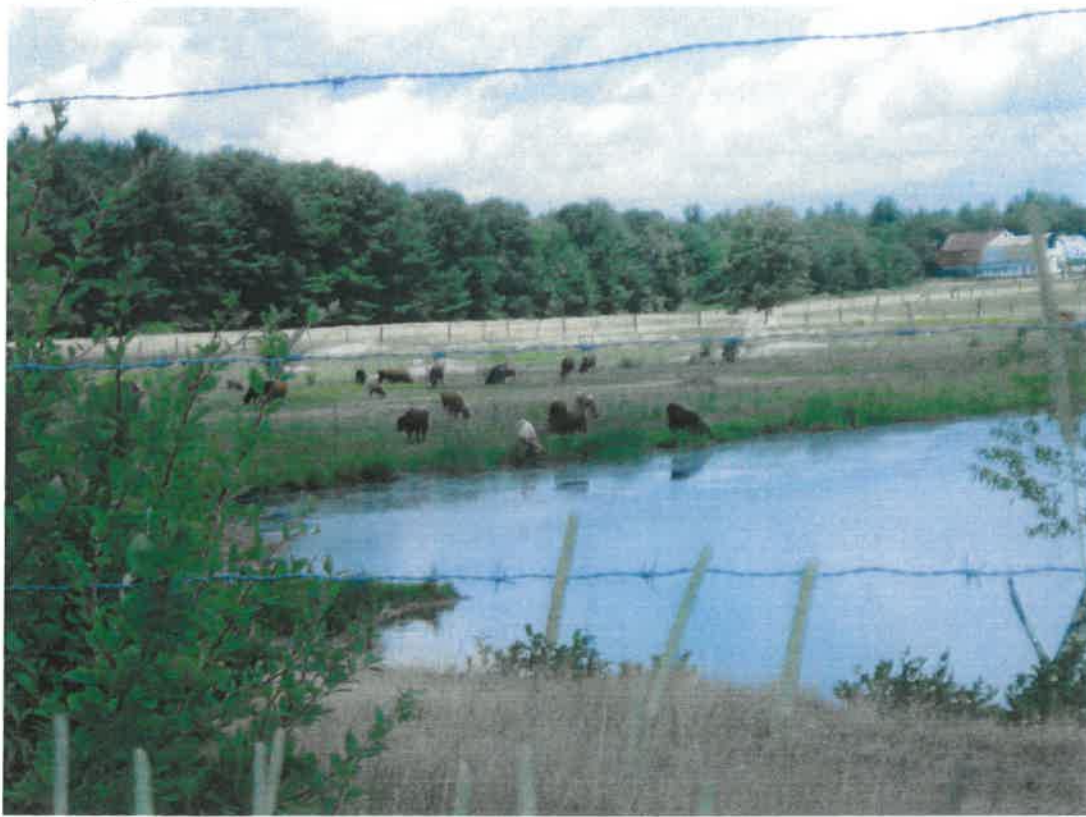
3. Some degradation is occurring to overall water quality at Wetland #6 by cows that are being allowed to drink directly from the pond. Best Management Practices for agriculture can provide good alternatives and, at the same time, provide better protection of the effected wetland.

wetland/seasonal stream; some evident degradation by cows

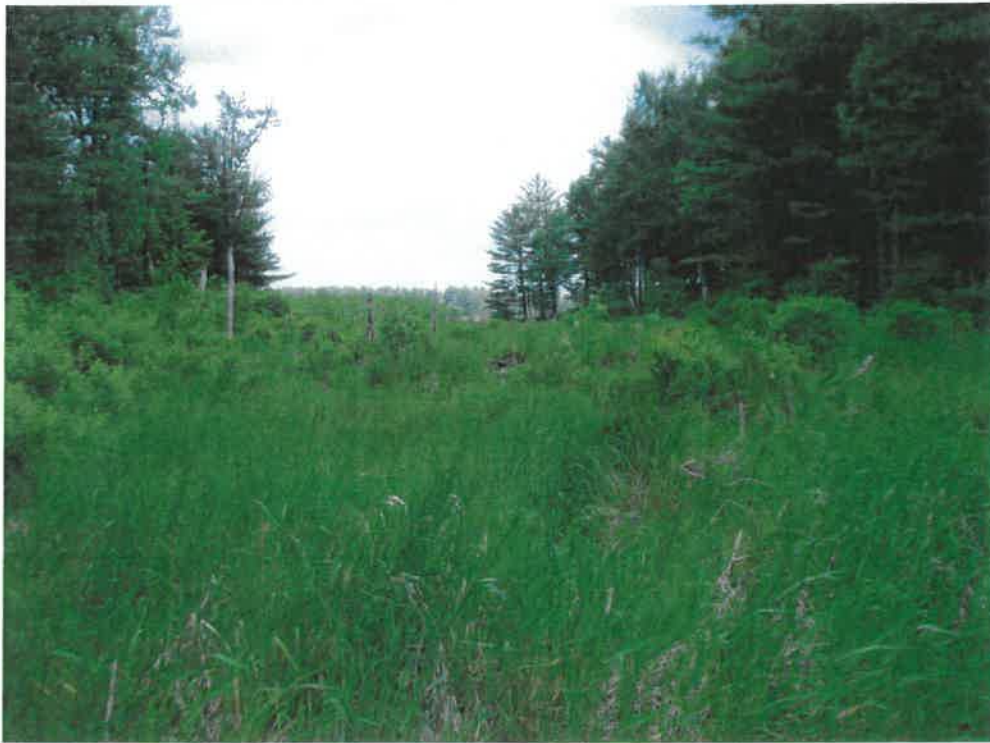
1. This is a view of the center portion of Wetland #7. It occupies a drainageway with an intermittent stream.

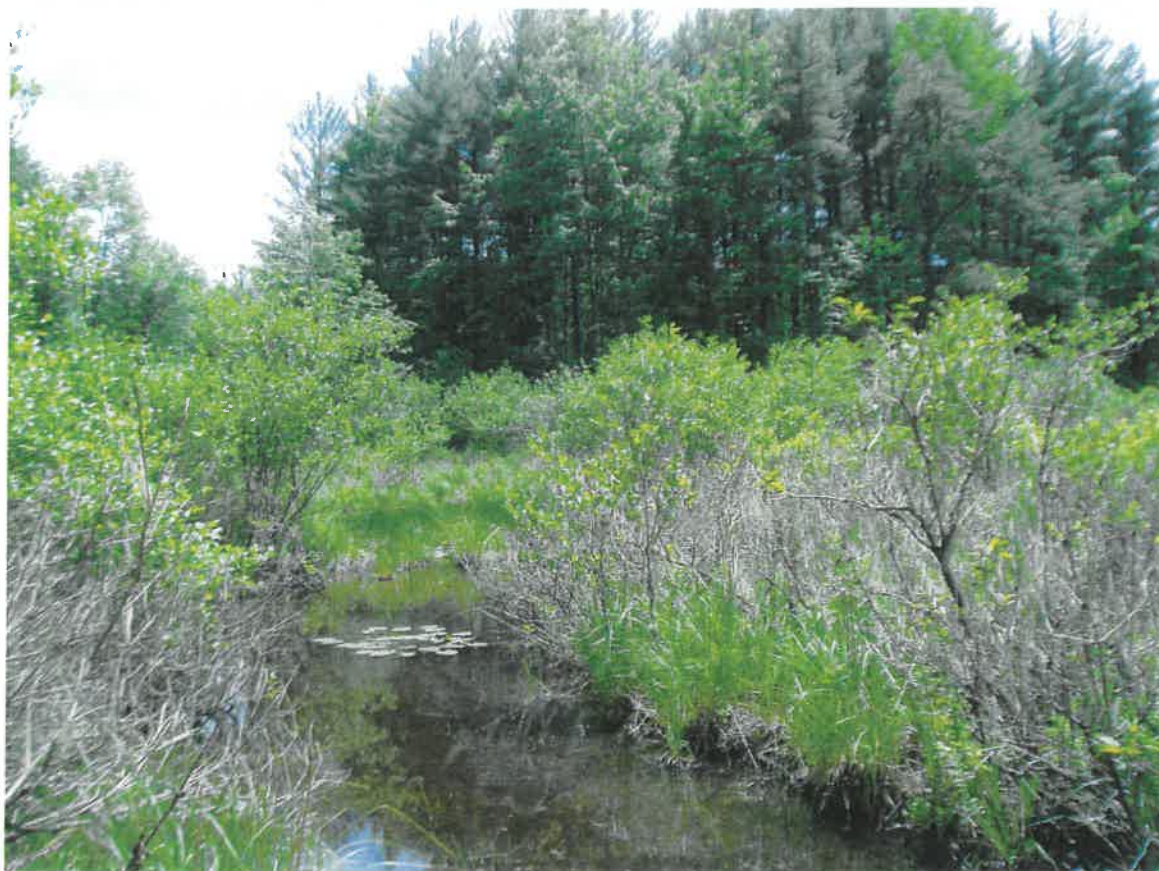
1. Wetland #8 flows into Wetland #7. North Road divides the two wetland systems. The wetland plant community is equally divided between emergent marsh and scrub-shrub species.

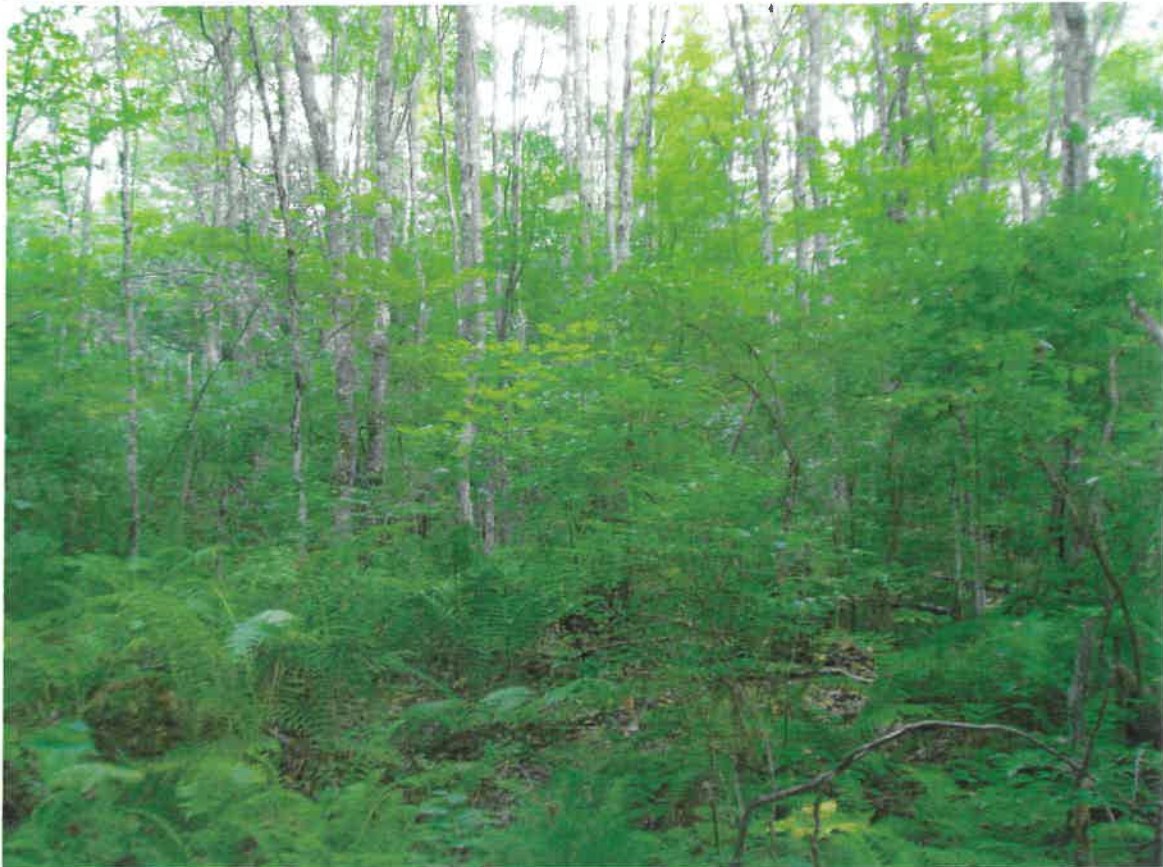
1. Wetland #9 contains a forested scrub-shrub plant community. The thick understory of shrubs provides excellent wildlife cover. A paved road, Brown Brook Circle, bisects this wetland.

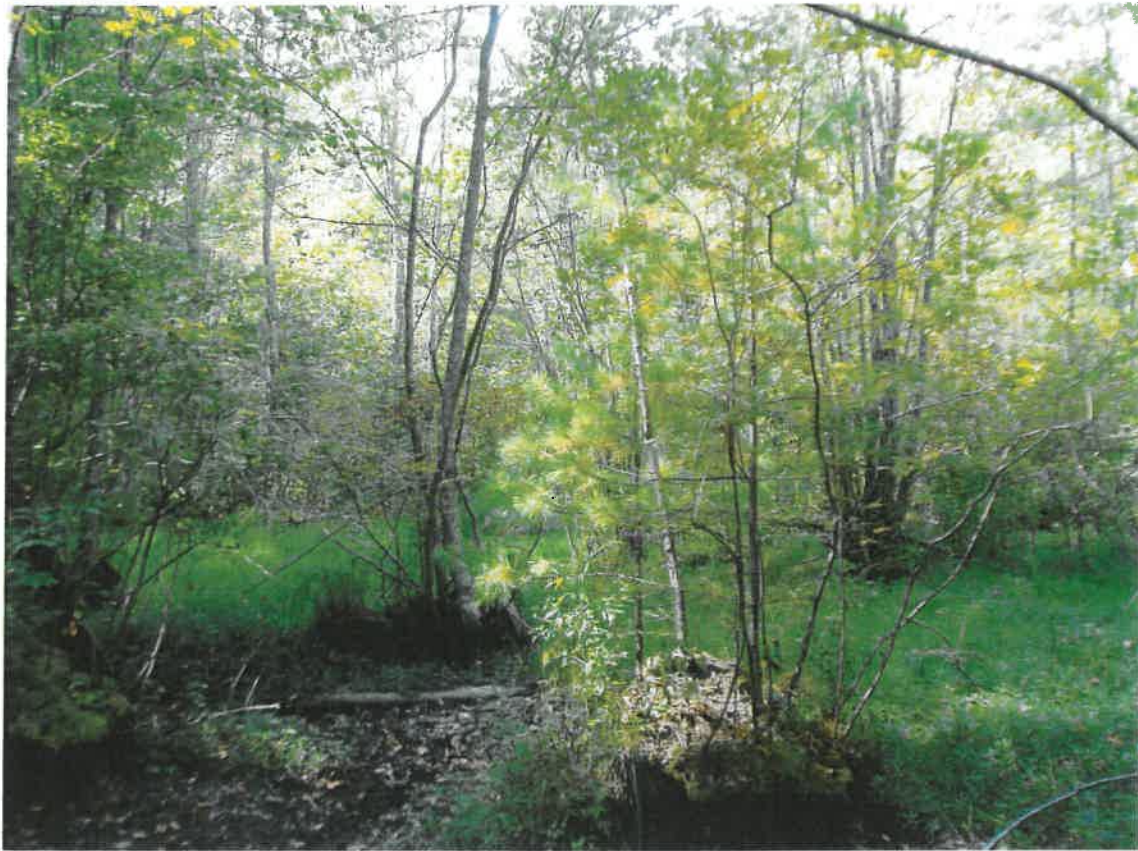
1. This is a view of Wetland #11 looking northwards. Its classification is forest – scrub-shrub. The observed pit and mound topography contained numerous depressions that would hold surface water during the spring months and provide potential habitat for breeding and egg laying amphibians.

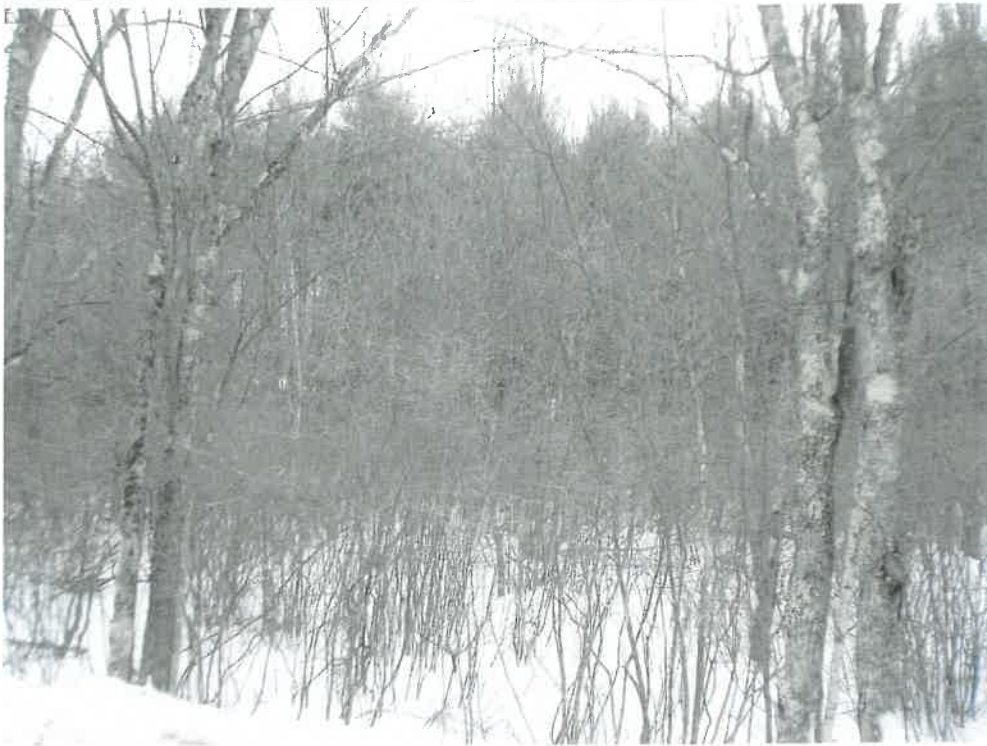
1. This is a view of Wetland #12 looking in a southeasterly direction. This is a forested scrub-shrub wetland which is hydrologically connected to Wetland #10.

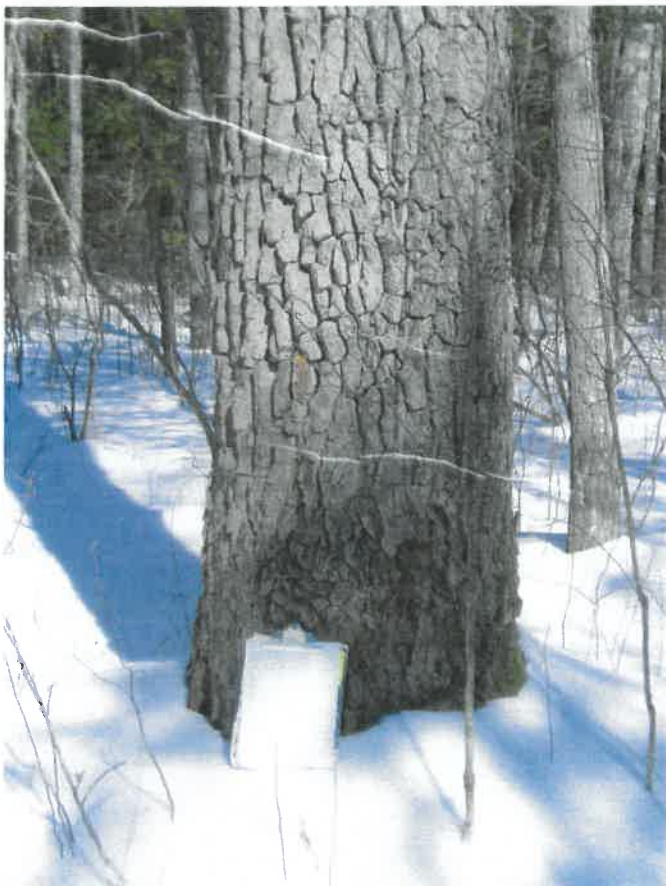
2. This large diameter black gum was observed within this wetland. These mature trees increase the overall diversity of the wetland and adjacent landscape.

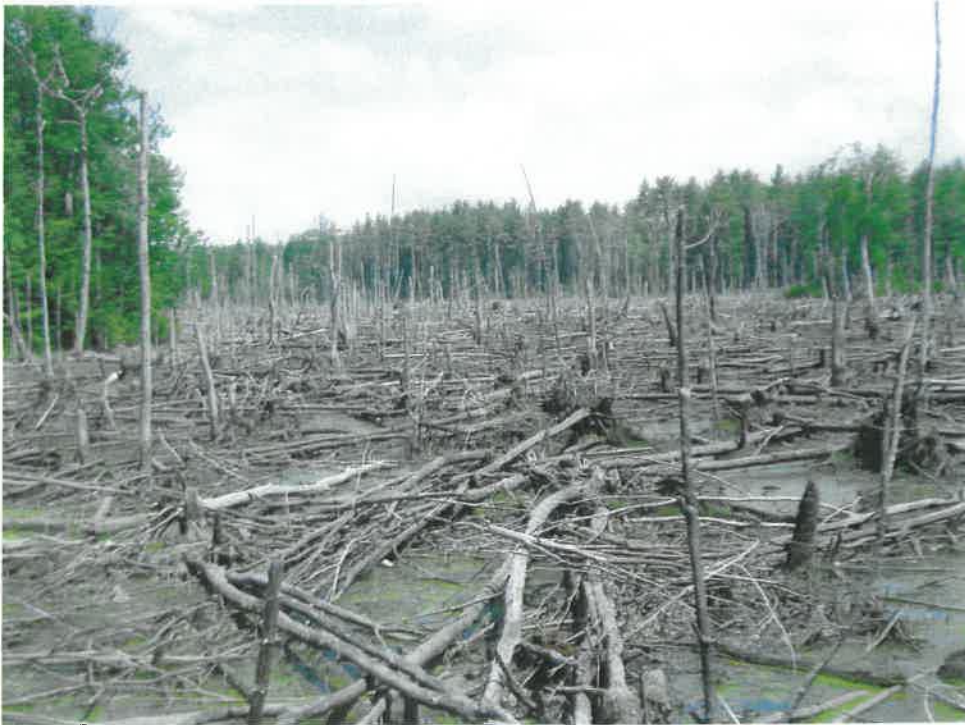
1. This photo is directed northwards from Shirken Road at Wetland #14. This wetland was previously occupied by a large beaver colony (five separate beaver lodges were counted). The once open water component has been since drained. Pre-existing beaver dams located on the northeast were observed to have been dismantled.

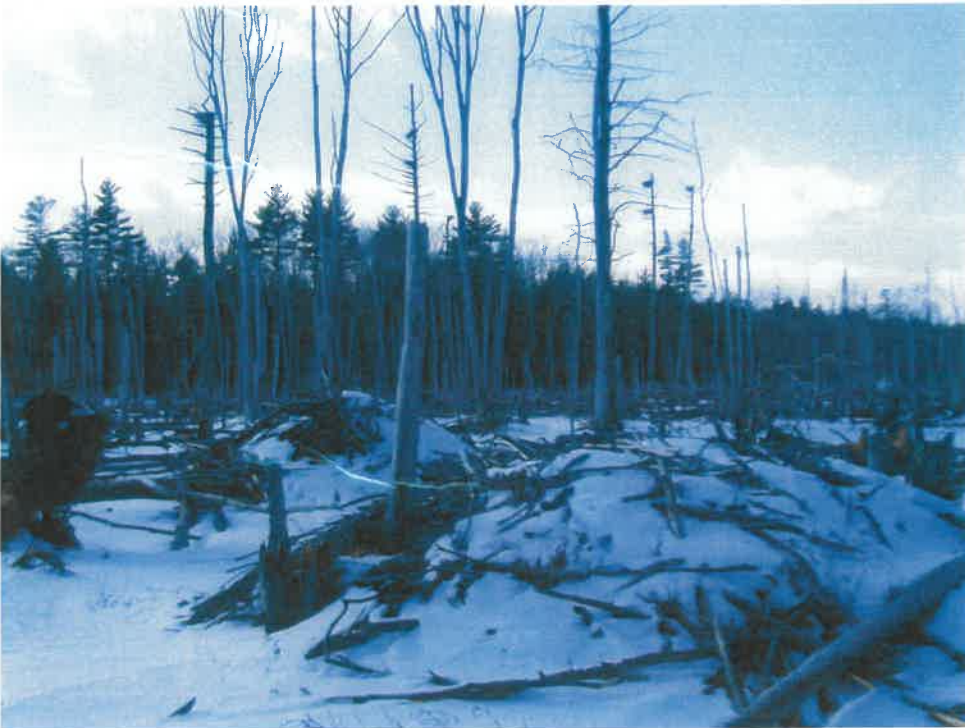
2. A total of 9 great blue heron nests were observed in the snag component within Wetland #14. This photo also shows two of the five beaver lodges that were situated in this prior beaver flowage.

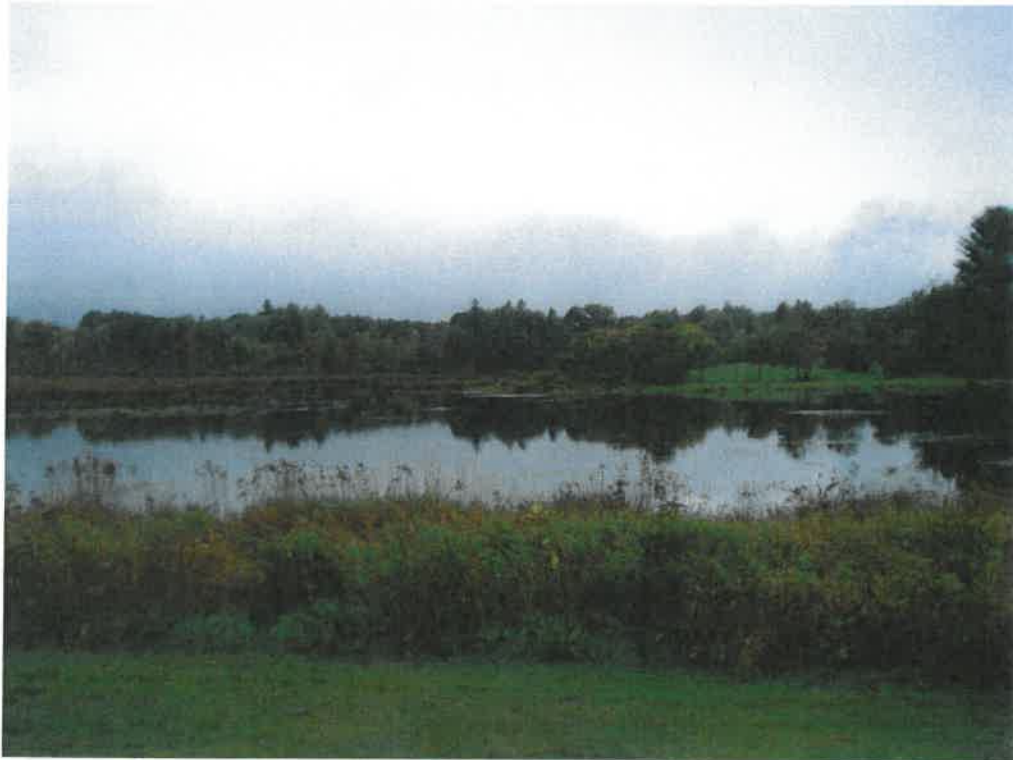
1. Wetland #15 is one of the larger wetland systems found in Fremont. This photo shows the open water component that is situated on the northeast section of this wetland.

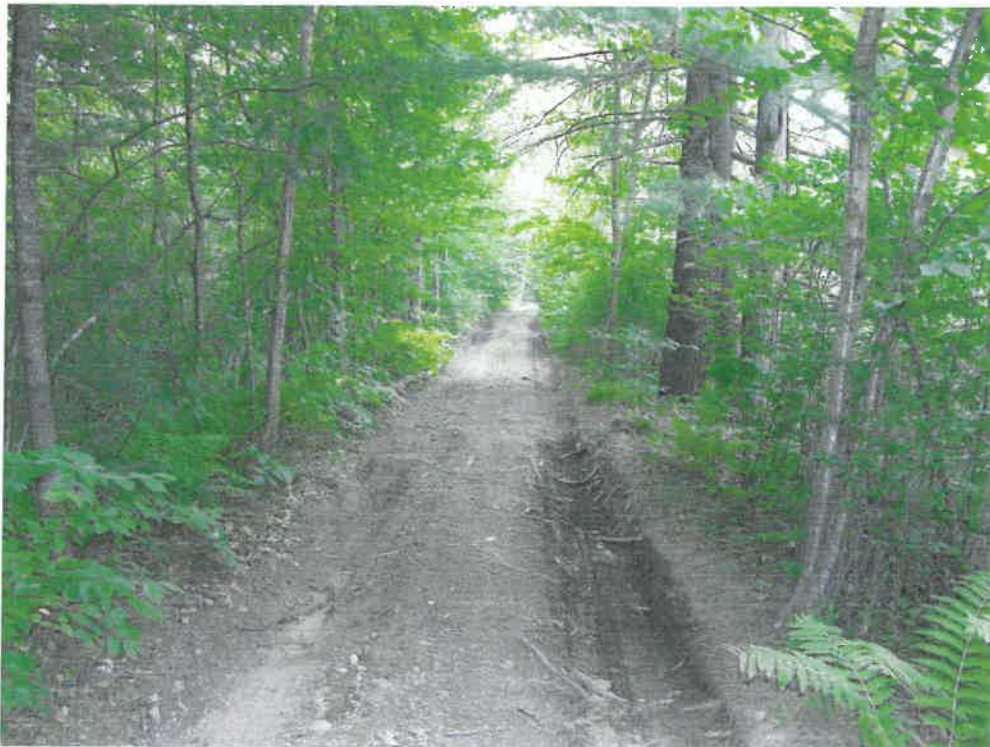
4. This photo shows the ATV trail that bisects the northeast section of this wetland. West Environmental, Inc. is recommending that this ATV trail be removed to restore the wetland's original connection. This may fulfill a future mitigation requirement by a potential developer.

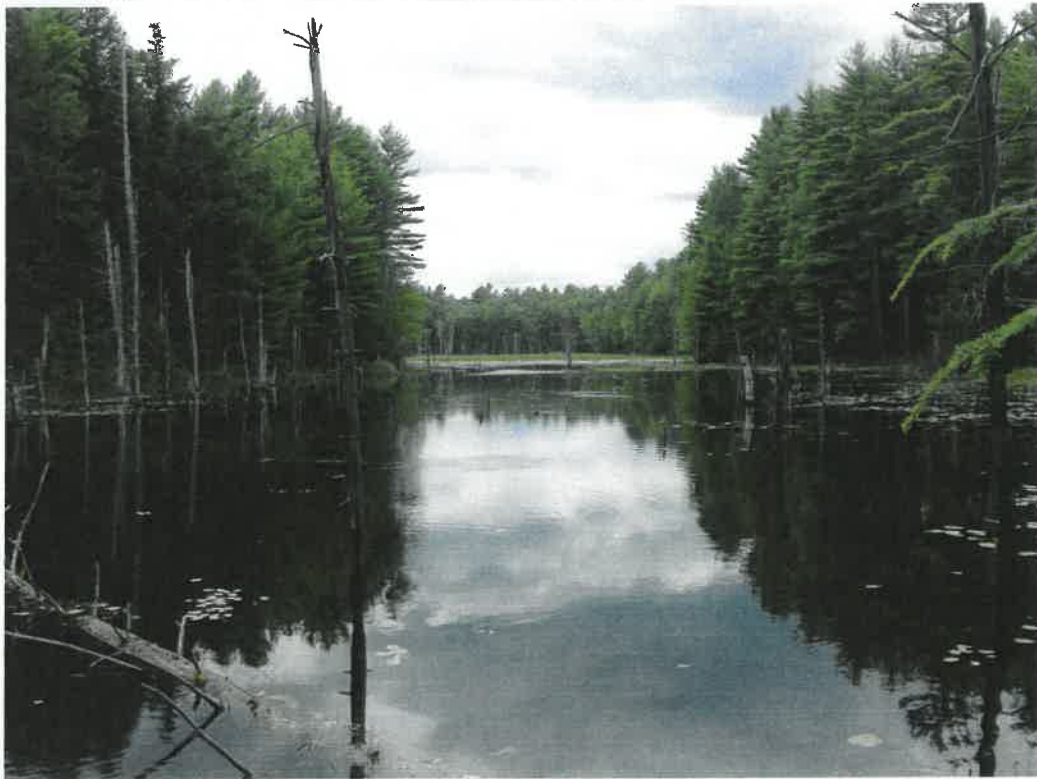
1. This is a view of Wetland #17 looking west from the beaver dam. This wetland has deep marsh in the eastern end and shallow marsh in the western end.

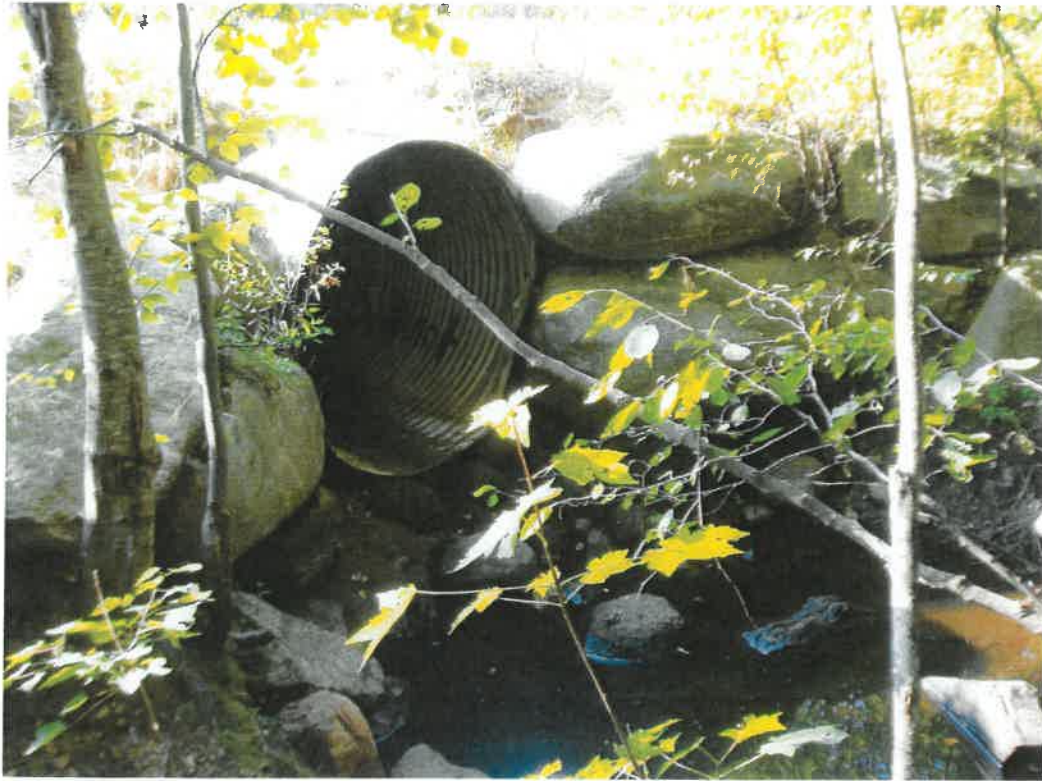
3. An elevated culvert was noted at the stream crossing beneath Taylor Road. Its elevation probably severely restrains passage of fish into the upper reaches of this perennial drainage.

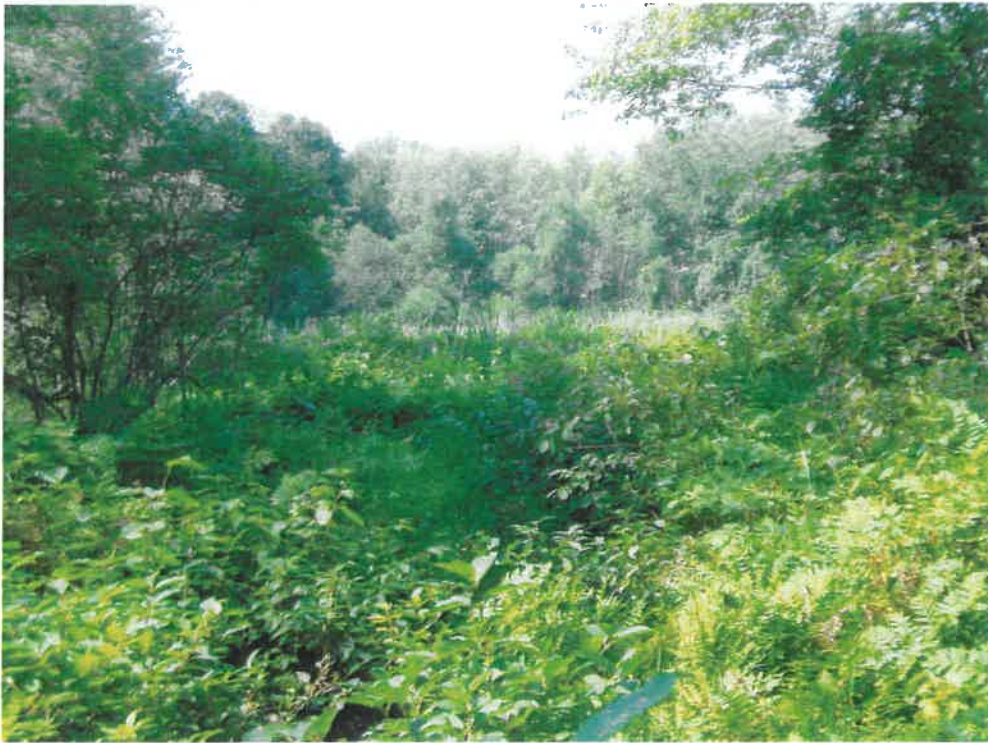
1. The main component of Wetland #45 is scrub-shrub / emergent. This wetland is situated adjacent to a prior oxbow of the Exeter River and appears to function as a spillover area during cyclical river flooding.

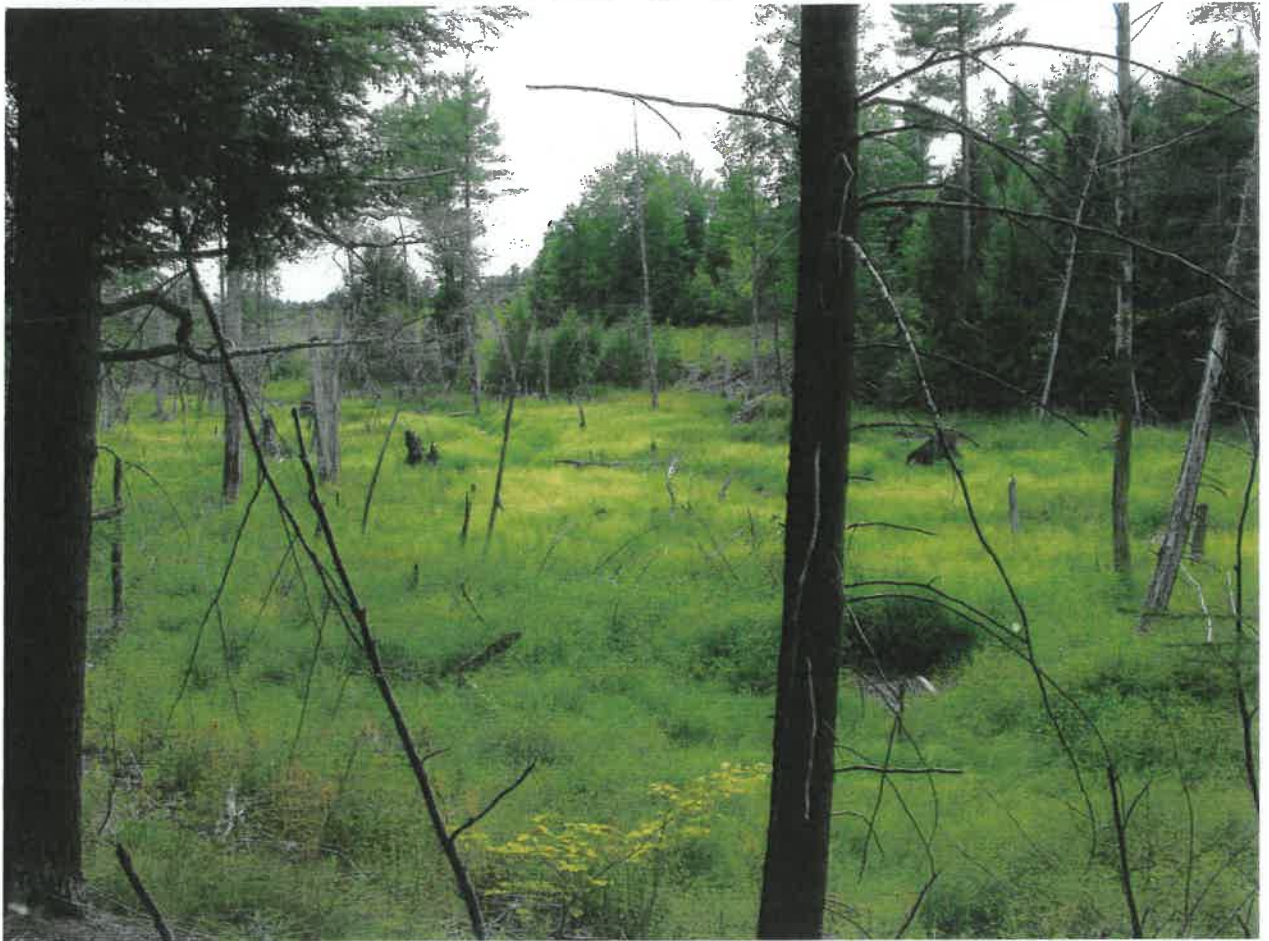
1. Wetland #52 is an old beaver pond that has recently been drained and has dead trees and shallow marsh habitat.

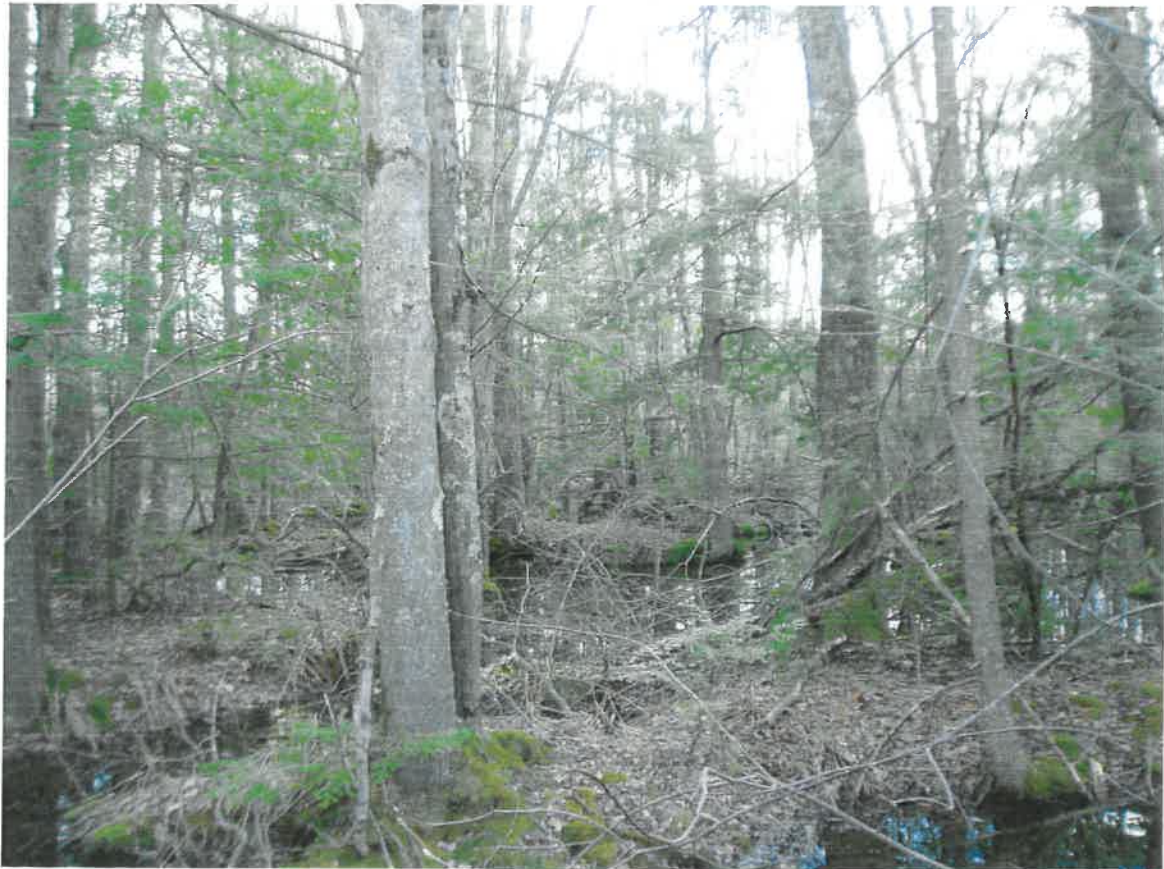
1. Wetland #54 is a forested wetland. This photo shows the pit and mound topography, the coniferous understory, and hydrological regime.
