# **NHDES WETLAND PERMIT APPLICATION FOR**

**Martin Road over Brown Brook Bridge Replacement  
Fremont, New Hampshire  
Bridge No. 155/133**

**April 2023**

***Prepared by:***  
**Stantec Consulting Services, Inc.**  
**5 Dartmouth Drive, Suite 200**  
**Auburn, NH 03032**

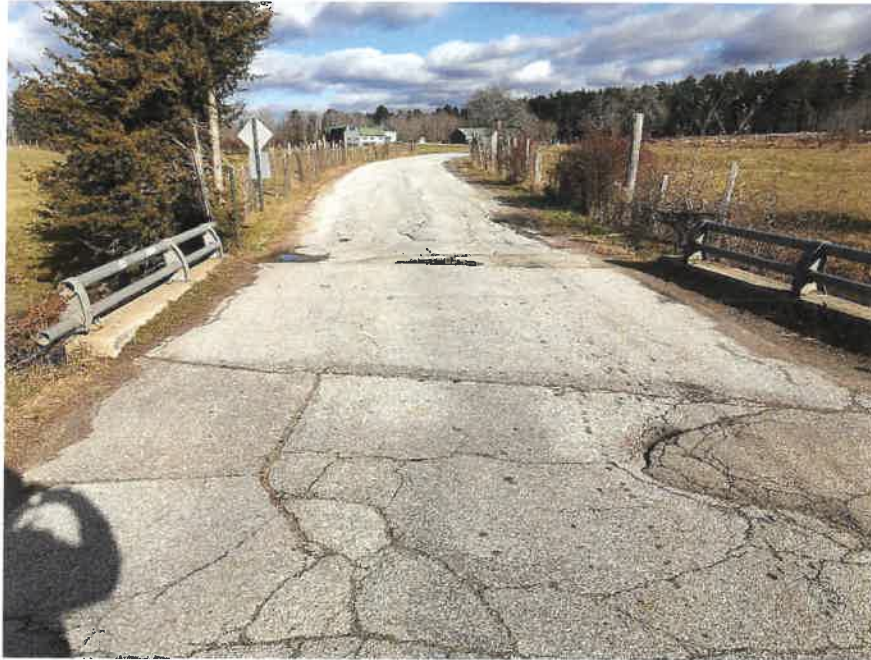
Photo 5- Standing south of Martin Road bridge looking northerly along Martin Road at the bridge to be removed and 100-foot prime wetland buffer areas along the roadway edge to be impacted with the new bridge, roadway approach and guardrails. Taken December 3, 2021

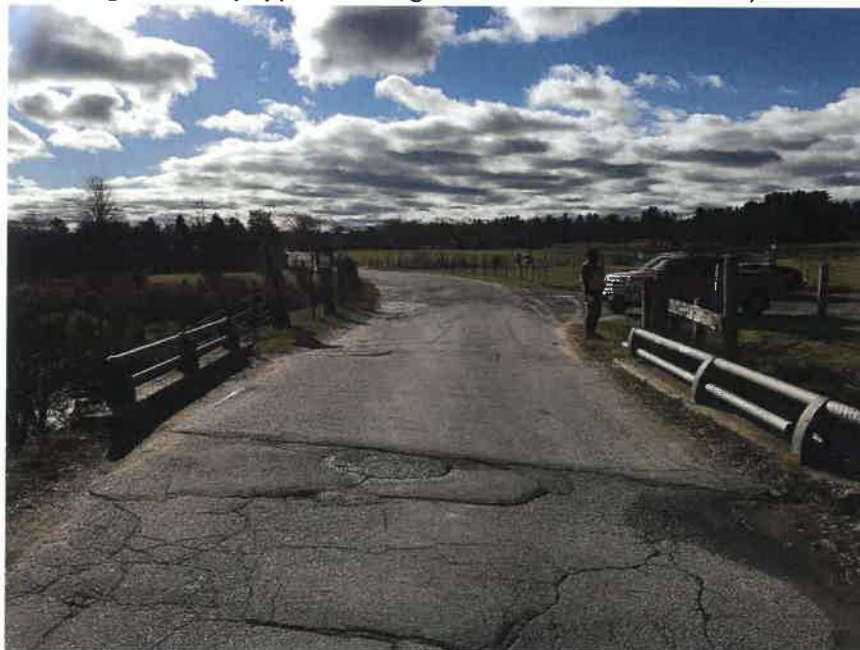
Photo 6- Standing north of Martin Road bridge looking southerly along Martin Road at the bridge to be removed and 100-foot prime wetland buffer areas to be impacted along the roadway edge with the new bridge, roadway approach and guardrails. Taken December 3, 2021

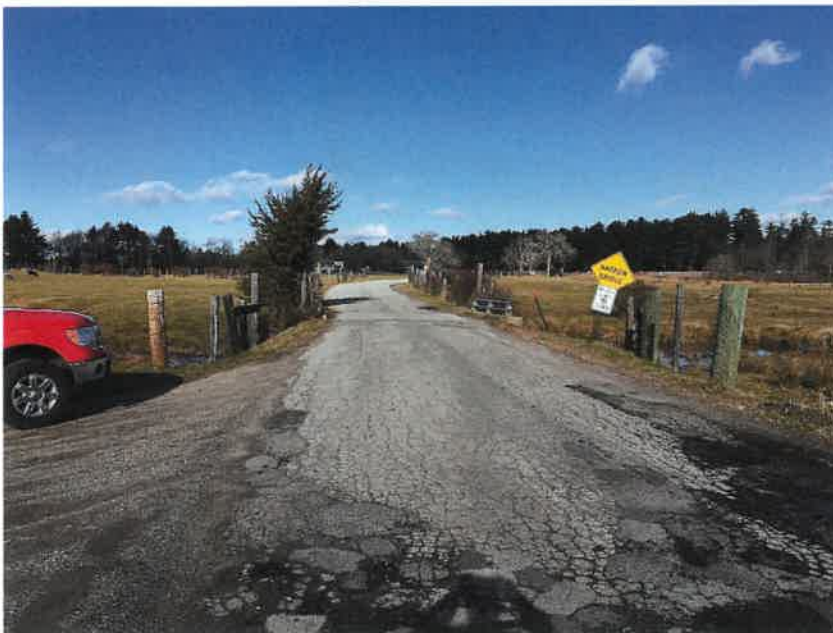
**Photo 18. Martin Road stream crossing (flow is from left to right)**

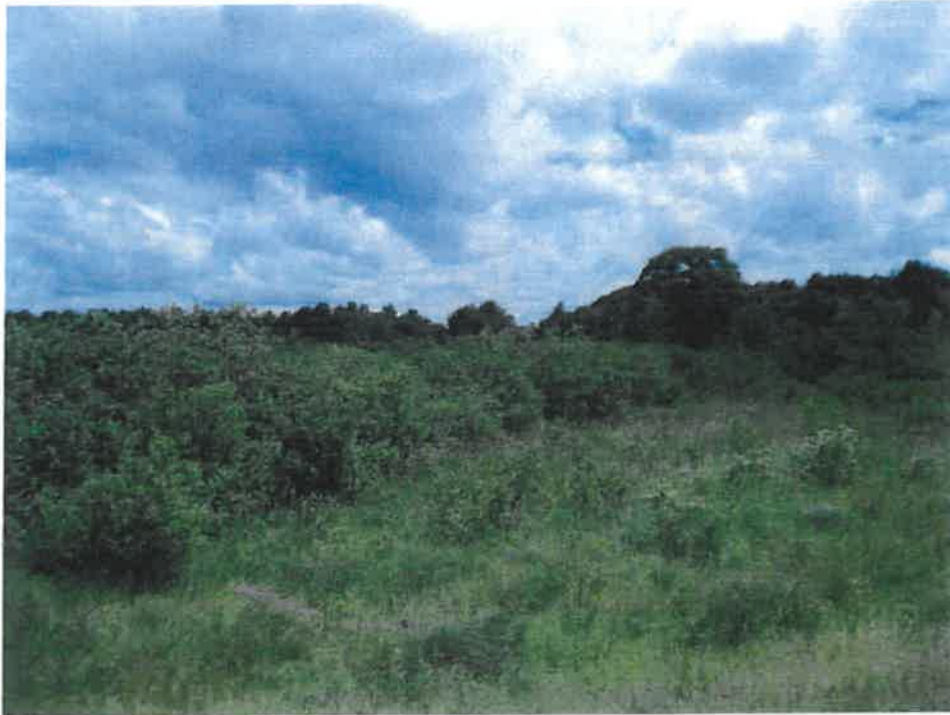
1. Wetland #5 consists of a wet meadow – emergent marsh – scrub-shrub plant community. Brown Brook, a perennial stream, flows in a southeasterly direction through the wetland.

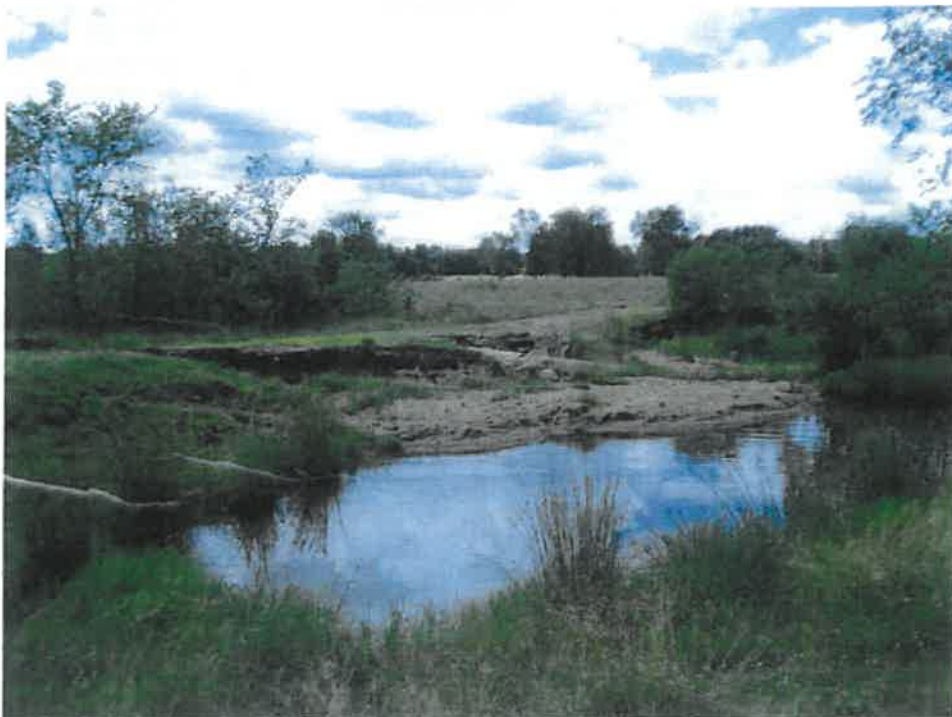
2. It appears that earlier flood events have caused disturbance (sediment deposition) in a section of this wetland where an access road was overtopped with water.

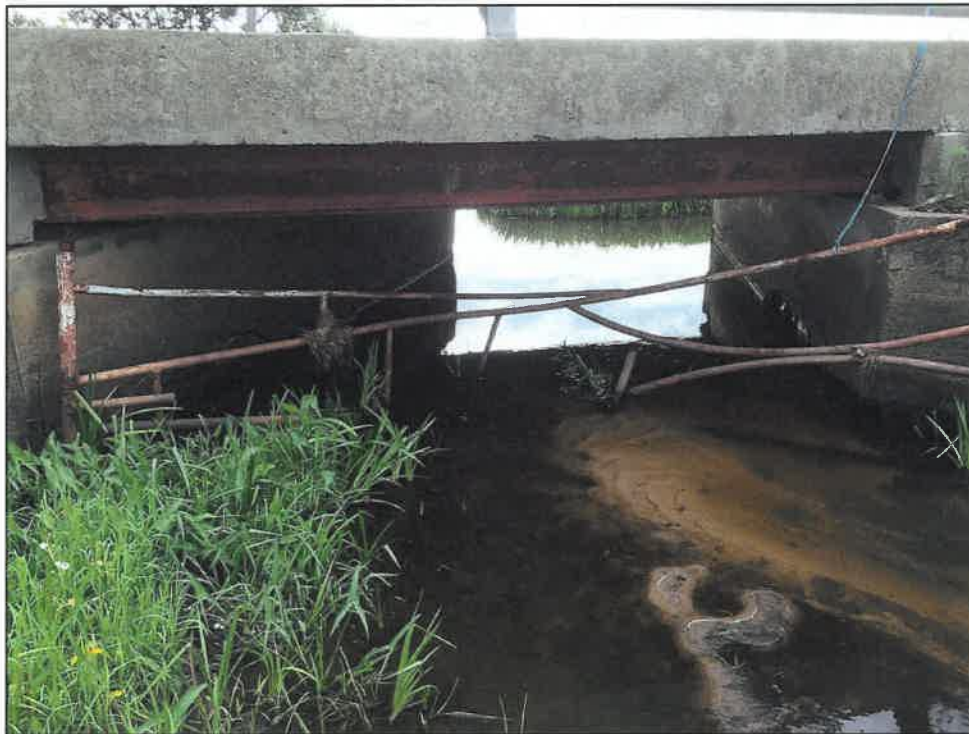
**Figure 2-2: Existing Bridge**

The bridge is located in the Town of Fremont in Rockingham County, New Hampshire. It is designated as Bridge No. 155/133 in the State's inventory. Martin Road connects Fremont Road and North Road and runs north to south. The existing bridge is located about 2,500' north of North Road, which runs east to west. The Martin Road Bridge over Brown Brook (**see Figure 2.2 below**) is a single span structure originally constructed in 1930. The structure consists of a cast-in-place concrete deck on steel girders, which are set on reinforced concrete abutments. The original structure is approximately 21'-6" feet wide (out-to-out). The bridge clear span is skewed and is 12'-3" at the inlet and 10'-2" at the outlet. The height varies along the length between 4'-0" and 4'-5". A fence gate, presumably to prevent farm animals from entering the waterway, is located at the upstream side of the bridge.

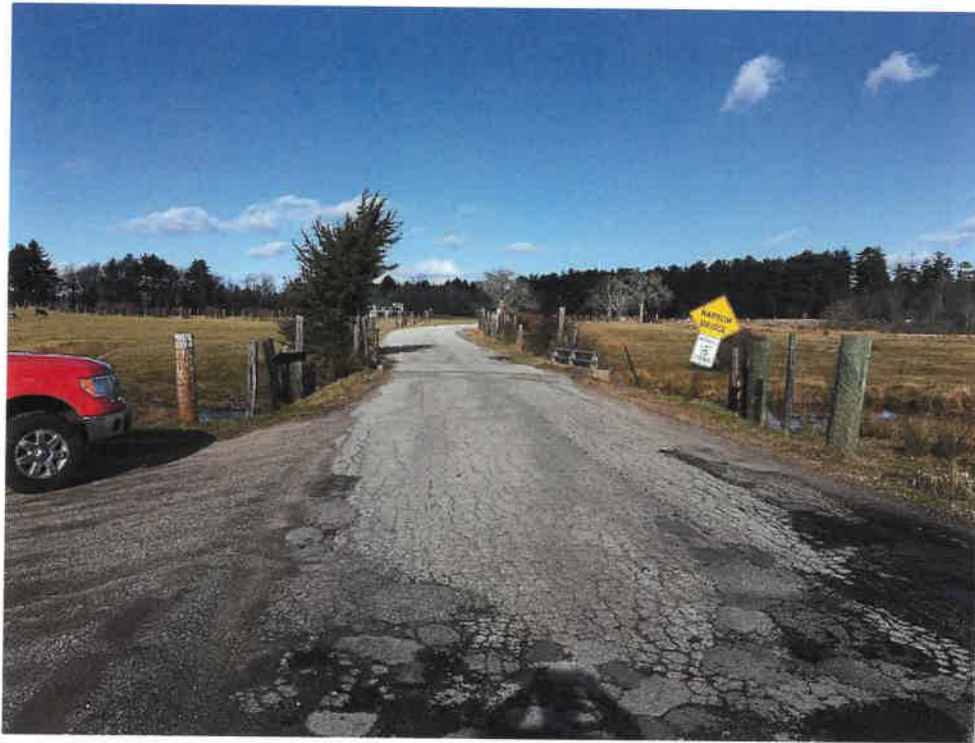
**Figure 2-3: Roadway Crossing at Bridge (looking north)**

The roadway alignment of Martin Road is on a short tangent section between horizontal curves which both curve to the east. The roadway varies in width at approximately 18-19 feet north and south of the bridge. The existing pavement is in very poor condition. There is a gravel driveway located at the southwest quadrant just south of the bridge.
