DRAINAGE ANALYSIS

EROSION AND SEDIMENT CONTROL PLAN

PPM TOWNHOMES
Tax Map 3, Lot 37-3 & 37-1
Spaulding Road
Fremont, NH 03044

Prepared by:
Jones & Beach Engineers, Inc.
85 Portsmouth Avenue
P.O. Box 219
Stratham, NH 03885
(603) 772-4746
October 6, 2021
JBE Project No. 20631

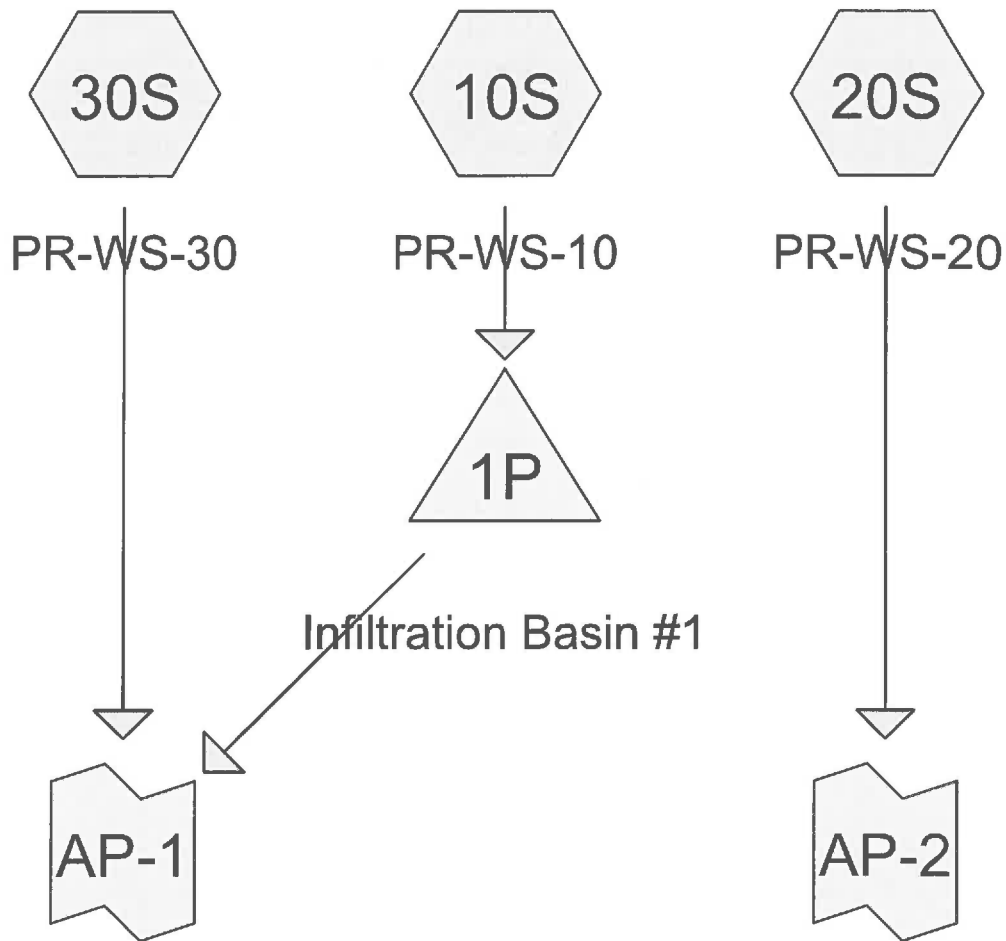
Analysis Point 1

Analysis Point 2

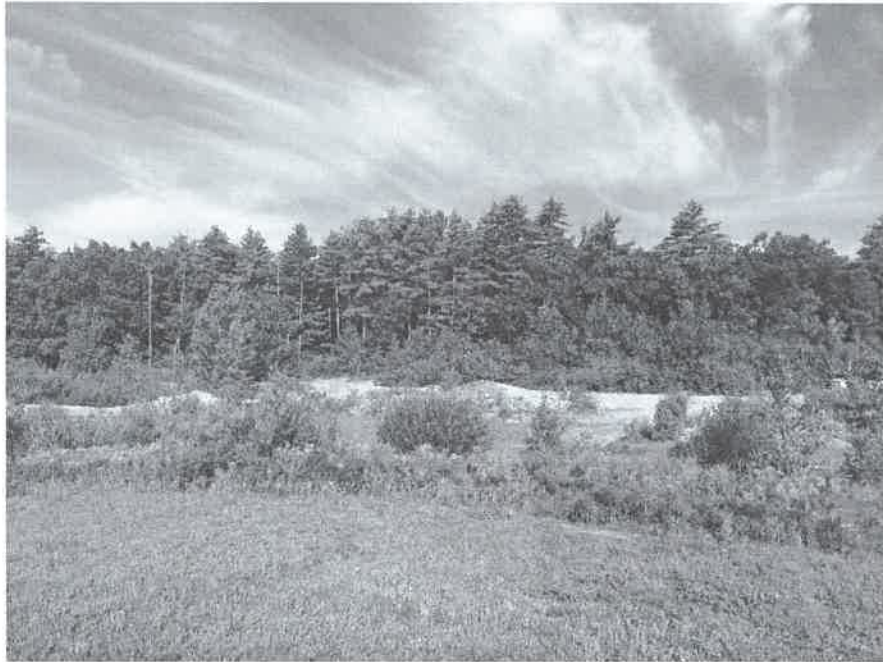
Photograph No. 1: Looking westerly into the Site from Spaulding Road.

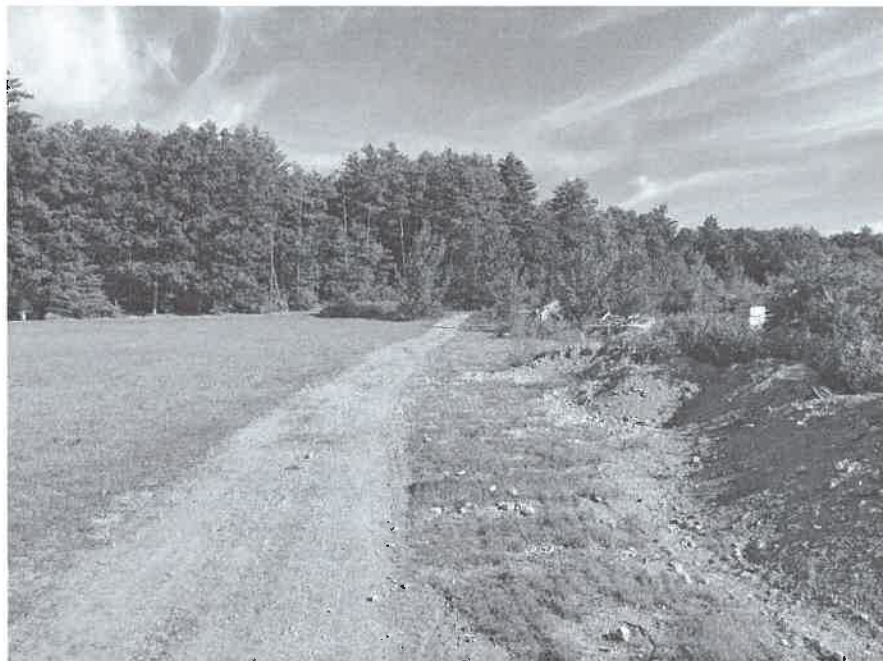
Photograph No. 2: Looking northwesterly at an existing access road from Spaulding Road in the southwestern portion of the Site.

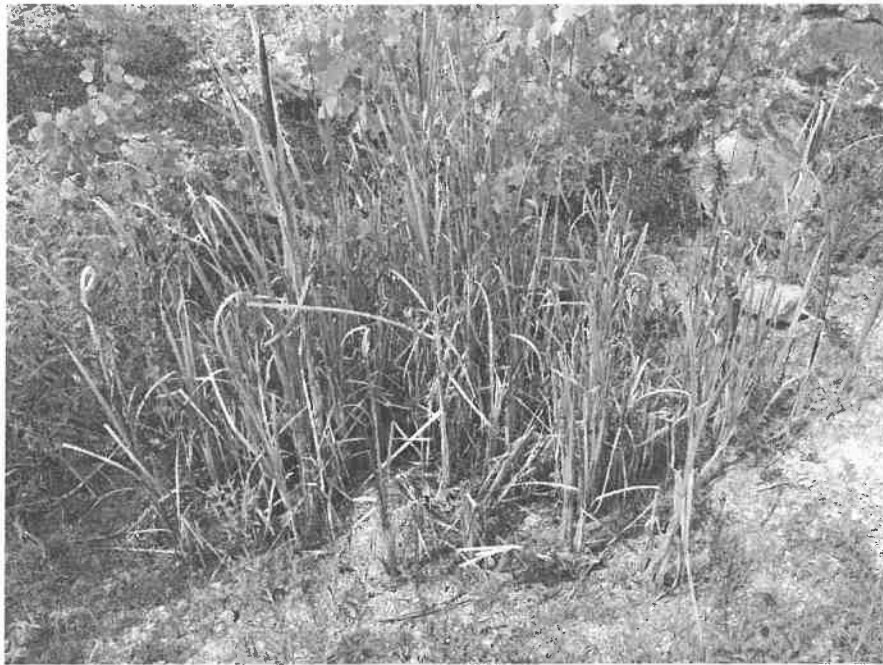
Photograph No. 3: Looking into a low-lying area in the center of the site containing broad-leaved cattail, purple loosestrife, and gray birch. This area has been previously excavated and hydric soils were not observed.

GZA identified one previous gravel pit excavation area with hydrophytic vegetation in the northeastern portion of the Site. This excavation area was reviewed for hydrology, hydric soil criteria and hydrophytic vegetation (see Wetland Determination data sheet, **Appendix C**). Dominant plants observed in the excavation area include willow, birdsfoot trefoil and tall scouring-rush. GZA concluded that although hydrophytic vegetation and a high groundwater table are present, the areas observed do not meet current hydric soils criteria, and therefore the assessed area is not a jurisdictional wetland. The hydrophytic plant communities observed on Site are what GZA believes to be the result of prior excavation of sand and gravel to groundwater table. This evidence can be seen in historic aerial photographs (see **Appendix D**). The gravel pit operation was not visible on the 2003 aerial, but is clearly present on the 2008 aerial. After discussions during the August 13, 2020 field work with the landowner, Tom Nisbet, GZA understands Mr. Nisbet was required by the town to add fill to low-lying areas as part of gravel pit reclamation on the site. Further, GZA notes the Site was delineated as part of the October 8, 2004 Site Plan labeled Coopers Corner, Tax Map 3, Lots 37 & 37-1, prepared by Eric C. Mitchell & Associates Inc (highlighted in yellow on figure). Wetlands were identified near Route 107 but not on the Site, which supports the assumption that hydrology was not present until excavation for gravel pit operation (see **Appendix E**).

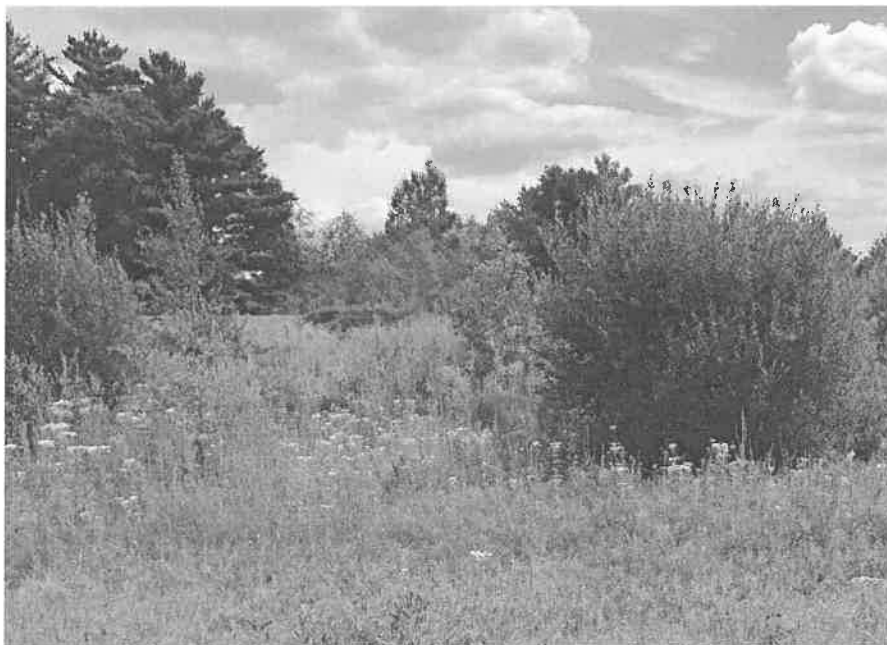
Photograph No. 4: Looking easterly at dense vegetation near the northern portion of the Site.

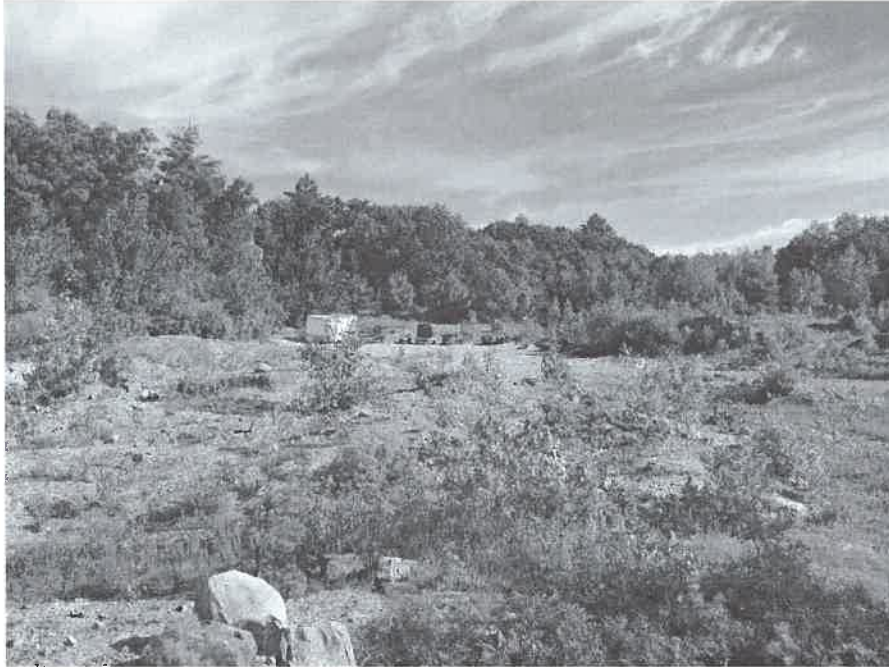
Photograph No. 5: Looking northerly toward the center of the Site at exposed ledge and existing gravel piles.

The Site consists predominantly of early successional habitat, with exposed ledge outcrops (see Photo Log, **Appendix B**). No wetlands or potential vernal pools were observed on Site during the wetland delineation. Vegetation in excavated areas throughout the site included birdsfoot trefoil (*Lotus corniculatus*), goldenrod (*Solidago spp.*), purple loosestrife (*Lythrum salicaria*), tall scouring-rush (*Equisetum hyemale*), blunt broom sedge (*Carex tribuloides*), umbrella-sedge (*Cyperus strigosus*), common rush (*Juncus effusus*), Canada rush (*Juncus canadensis*), boneset thoroughwort (*Eupatorium perfoliatum*), hollow joe-pye weed (*Eutrochium fistulosum*), sweet fern (*Comptonia peregrina*), Queen Anne's lace (*Daucus carota*), broad-leaved cattail (*Typha latifolia*), willow (*Salix spp.*), gray birch (*Betula populifolia*), and autumn olive (*Elaeagnus umbellata*).

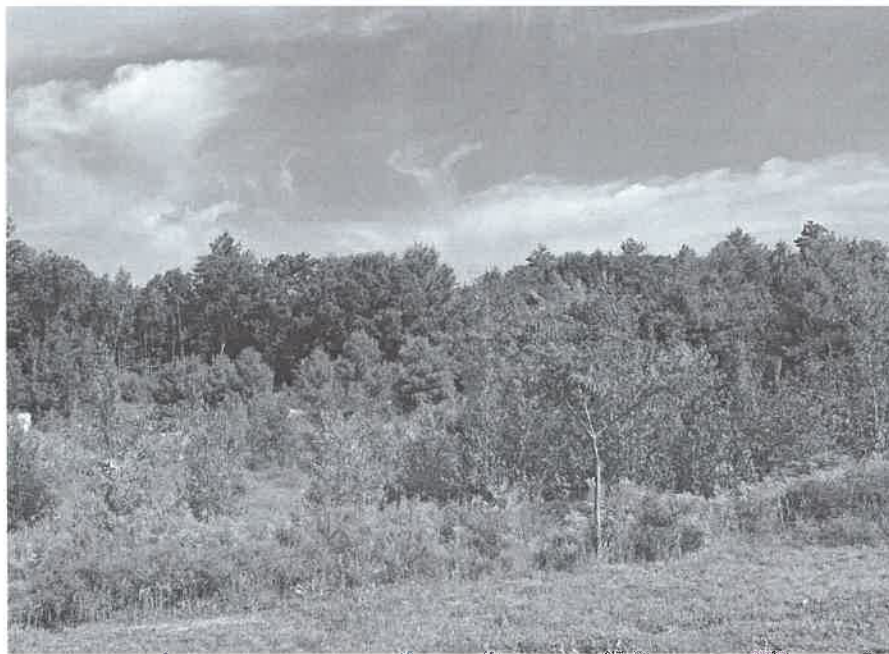
Photograph No. 6: looking northwesterly into dense vegetation from Spaulding Road.

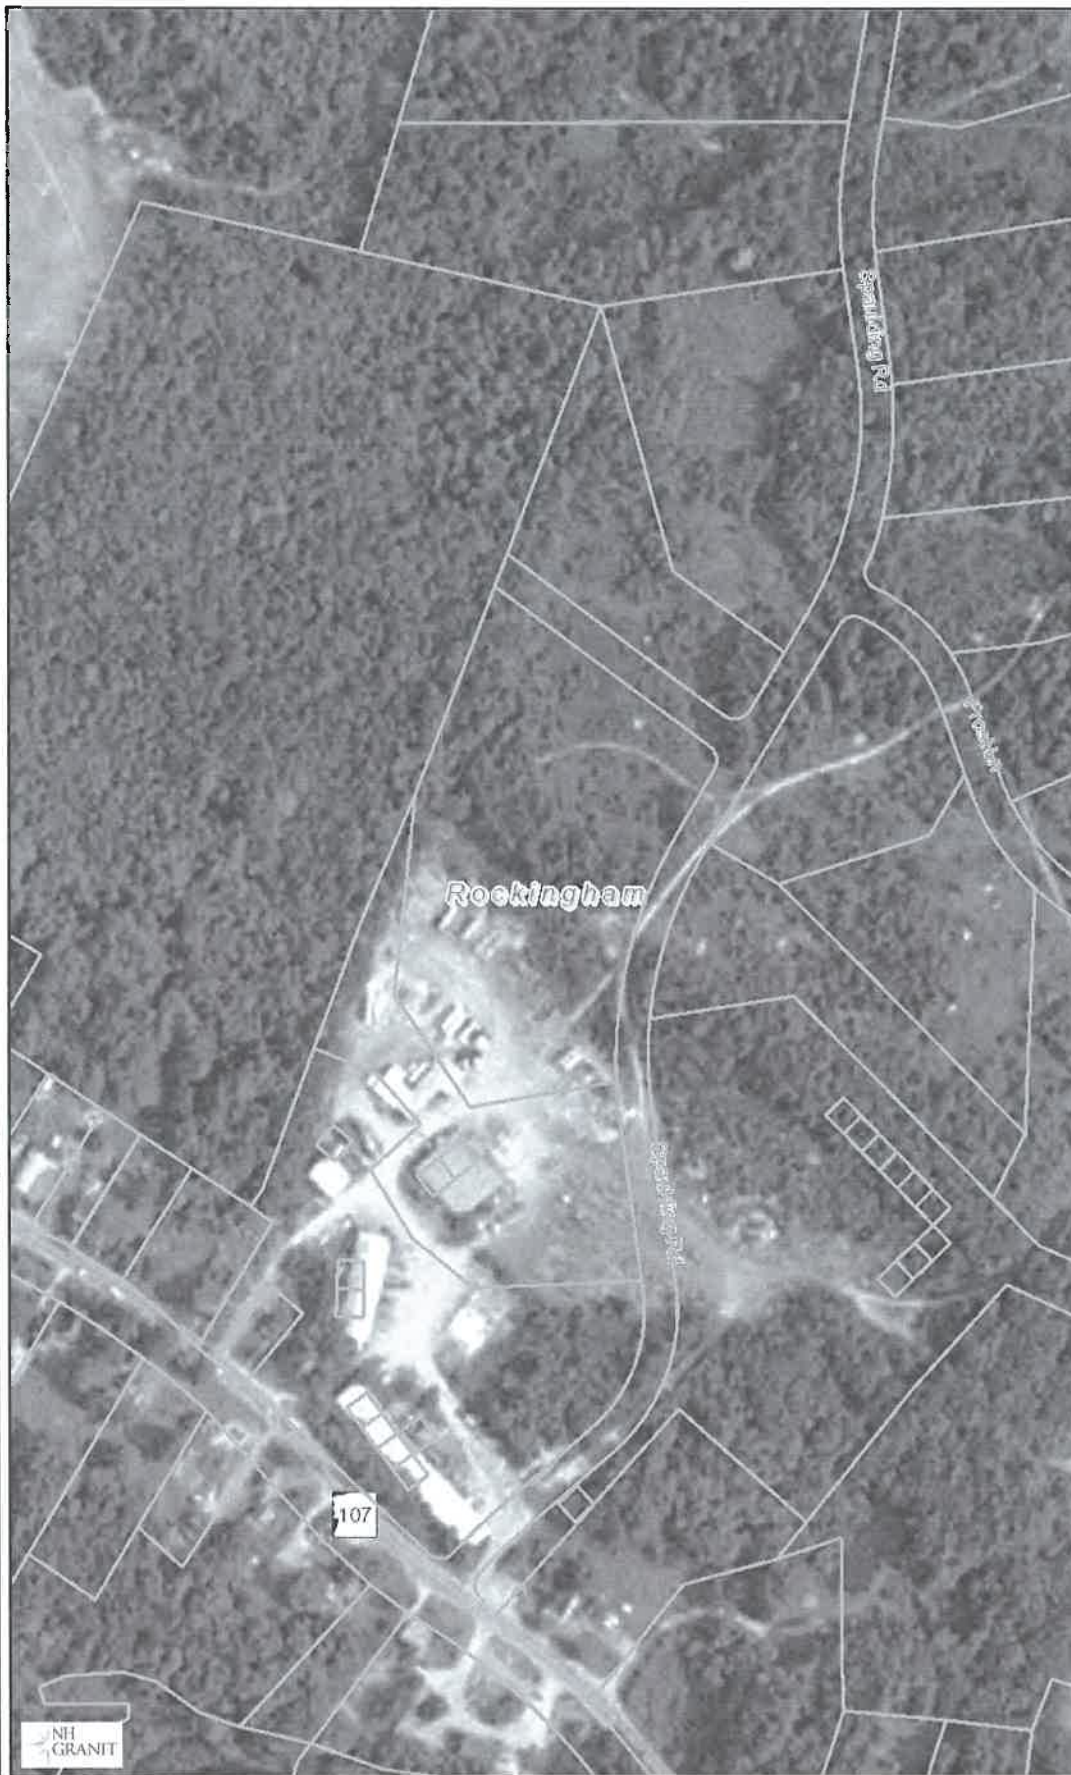
2003 Aerial

Typical conditions are not present on site. Sand and gravel have been excavated from the site at or near groundwater table.

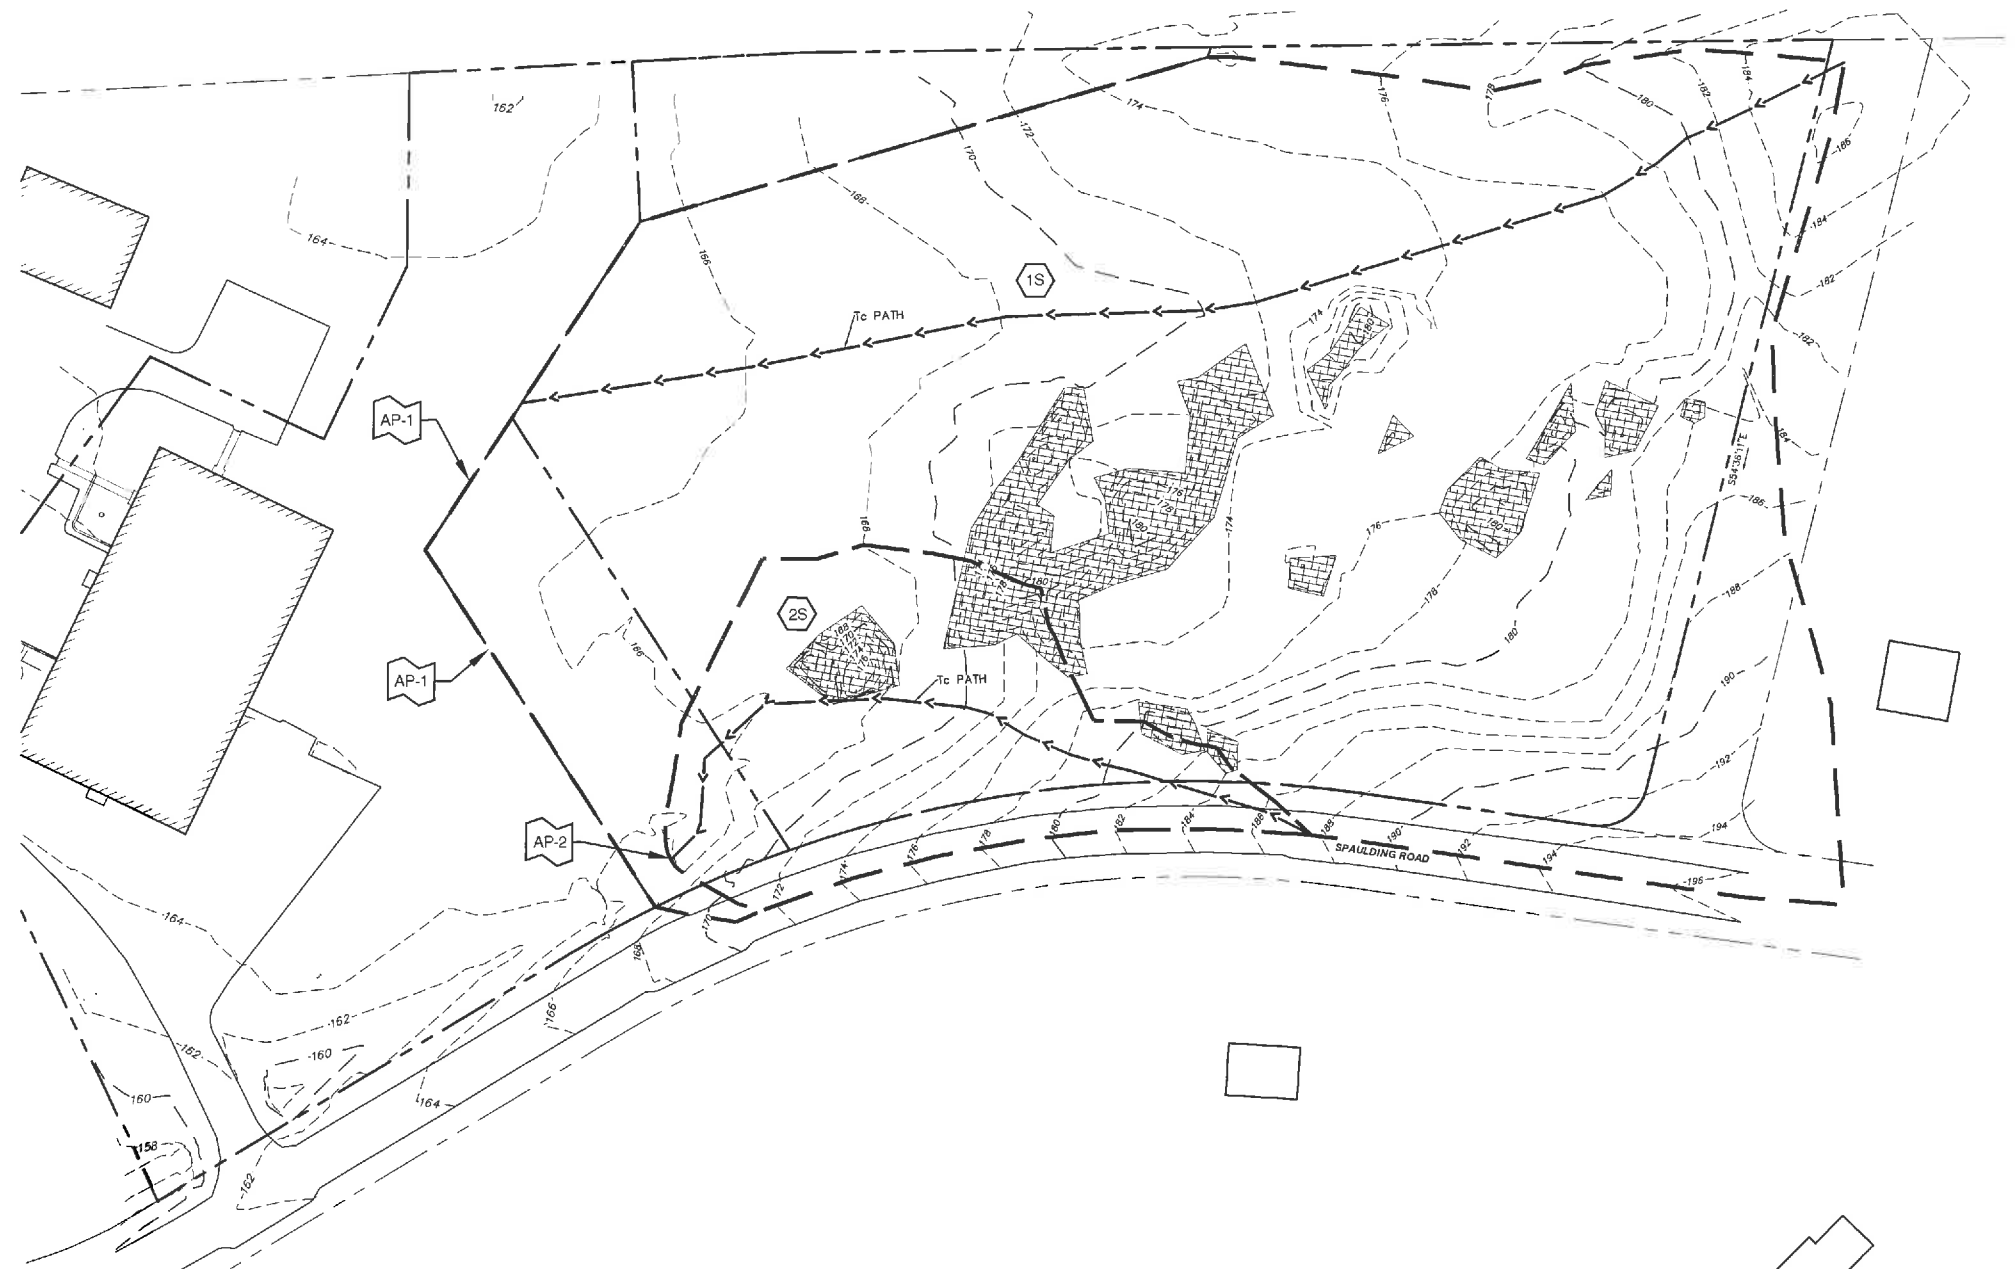
DRAWING No.
W1
SHEET 1 OF 2
JBE PROJECT NO. 20631

SUBCATCHMENT	---
BOUNDARY	---
SUBCATCHMENT	X
REACH	X
POND	X
TC PATH	---
WETLANDS	---
HISS SOILS	---
FLOW ARROW	---

The study area consists of the subject property and upstream contributing area. The study area contains 5.99 acres including offsite contributing areas. The existing site is currently undeveloped with the exception of a gravel driveway and parking area. The existing site features a high point located at the eastern corner of the subject parcel. The site drains to the southwest from this high point. A high point near the center of the subject parcel breaks stormwater and a smaller section of the site abutting Spaulding Road drains to an existing culvert. The Analysis Points are defined below.
