Sandown Road Bridge Overflow 086/055

Sandown Road over the Exeter River

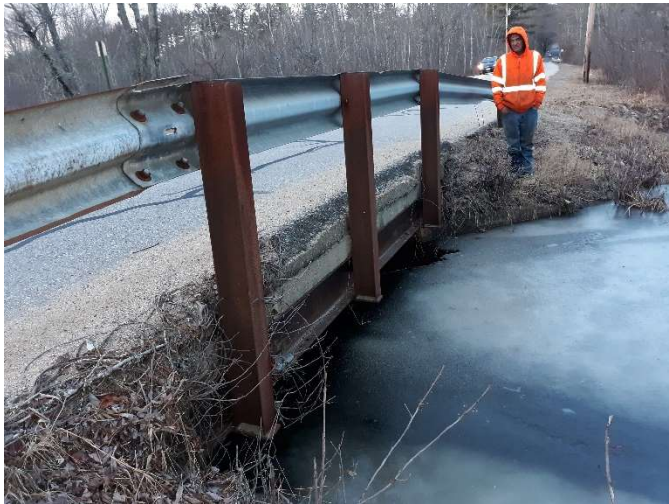
These before photos below depict each side of the bridge, which was slated for guardrail repair in the Highway Department 2019 operating budget. We were now faced with a much larger repair project, and successfully asked voters to amend the Bridge Capital Reserve Warrant Article at the 2019 Deliberative Session to be able to address the repairs. The beams (you can see at the edges in both photos, taken on January 10, 2019) were deteriorating and needed replacement. After engaging engineers that had been

previously authorized by the NH Bridge Aid Program, further inspection and investigation into records showed that the outside edge beams were the beams of concern.

The substructure (abutments) are in good condition (NHDOT rated as a 7 on a 0 to 9 scale), and it is recommended to keep the existing abutments and replace the superstructure (beams and deck); have the new bridge deck pre-engineered and prefabricated by US Bridge or equal; prepare existing abutments to receive the prefabricated bridge deck (with the knowledge that there may be additional necessary repairs to abutments that we would not be able to see until the pavement is pulled up); replace guardrail and complete minor approach roadwork in both directions to provide a smooth transition.

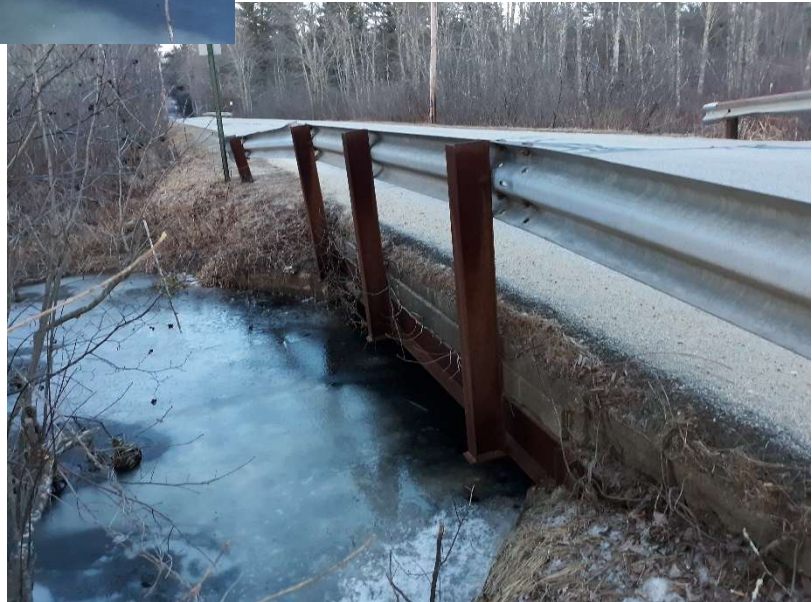
Engineers outlined a galvanized steel beam option with galvanized steel decking. This is described as a corrugated steel (like a metal roof) with deeper grooves that are filled with asphalt paving. Galvanized steel is more cost effective, no painting is necessary, and therefore is good in applications close to the water.

These systems are generally available pre-engineered and are prefabricated from the manufacturer, arriving on a flatbed truck, assembled in place, and laid into their final location. This method involves removal of the existing beams and deck, with the road closed during that time. The road did not need to be completely closed until the deck had to be removed. Lighting and traffic controls were installed and the bridge closed down for the day on April 2nd to install barriers for the one lane restriction, and from April 3rd until July 25th, was open for one lane of travel in the center span.

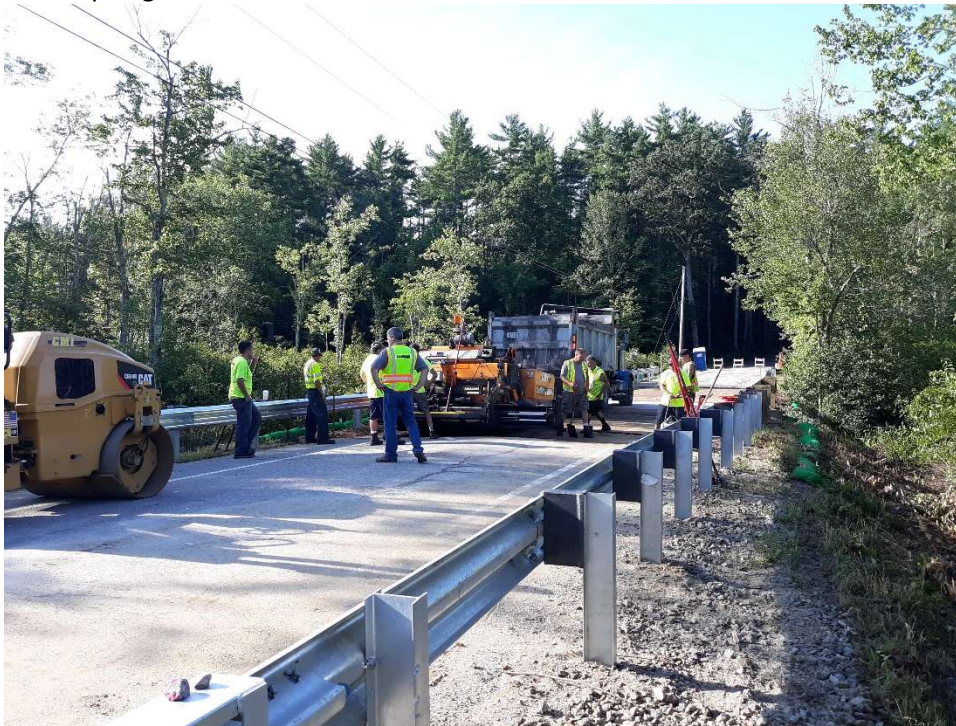
Thankfully the abutments did not need any work, and they were shimmed to receive the new beams and then the pre-fabricated deck was placed. Following that, the road was paved and the new guardrails installed. Actual construction work took just less than a month and we were successfully able to reopen the bridge on the morning of August 23, 2019 in time for busses on the first day of school on Monday August 26th.

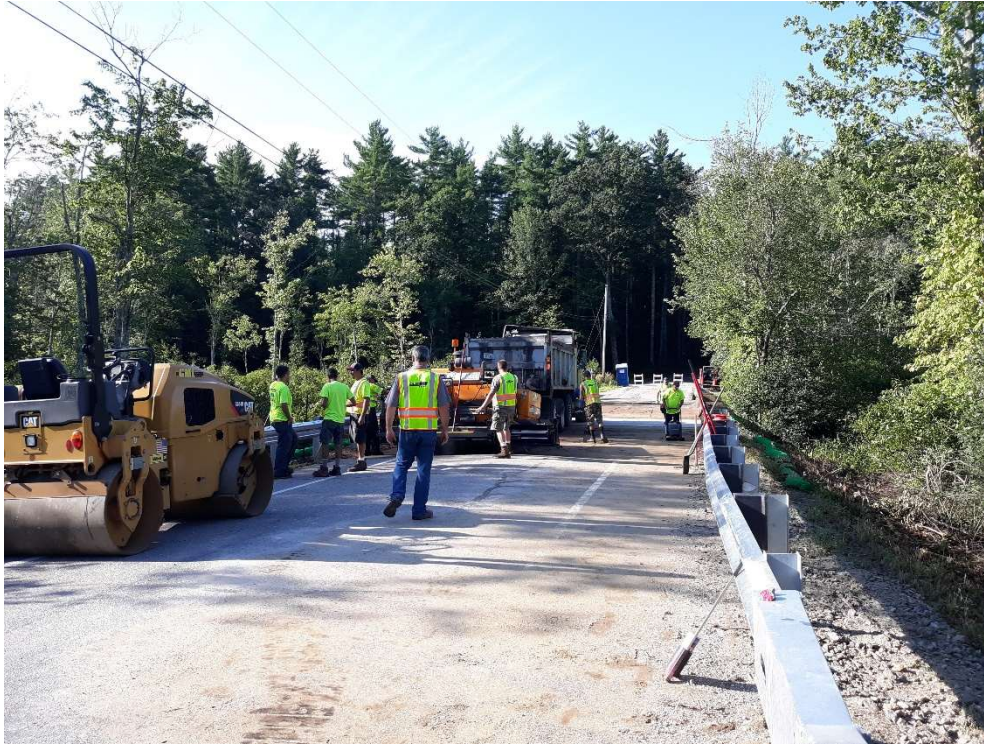
We are pleased to report that the bridge was done on time and slightly under the originally estimated budget. This is in large part thanks to the assistance of our Highway Department and their man hours.
